830 Covington Grove Court, Bowling Green, KY

Property Inspection Report

**830 Covington Grove Boulevard
Inspection Prepared For: Ana Marie Gierhart
Agent: Tyler Chamings -**

**Date of Inspection: 9/13/2024
Year Built: 1995 Size: 6598
Weather: Cloudy/Raining and 76 degrees**

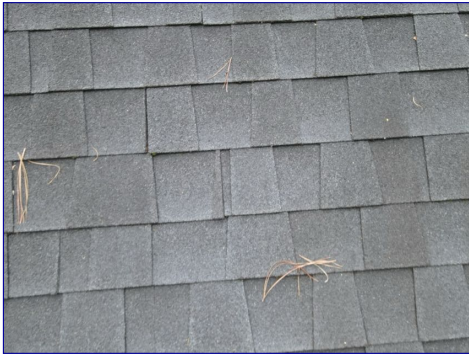
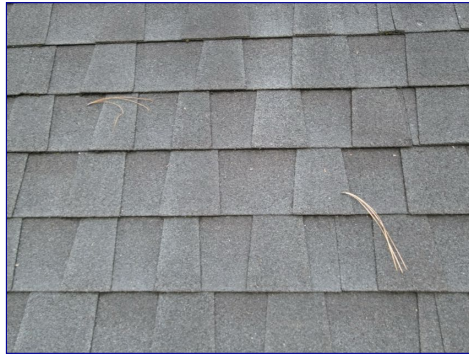
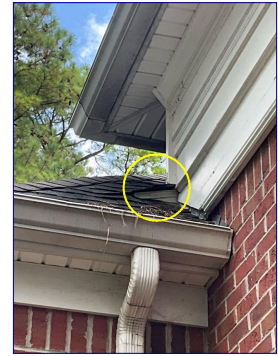
• There is evidence of a leaking roof junction over the front part of the garage, where the garage meets the house. There is moisture staining on the garage ceiling, this area is not accessible from the attic, recommend a qualified contractor to evaluate further and repair as needed

Roof junction above the water stains/damage in the garage

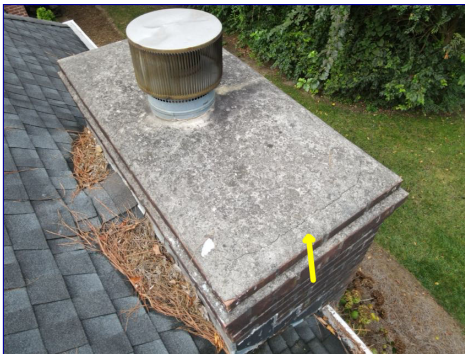
• The concrete chimney cap is cracked. Recommend a licensed professional evaluate and seal the cracks/replace the chimney cap as needed.

Cracked chimney cap

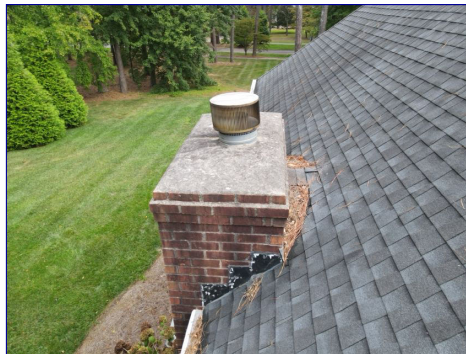
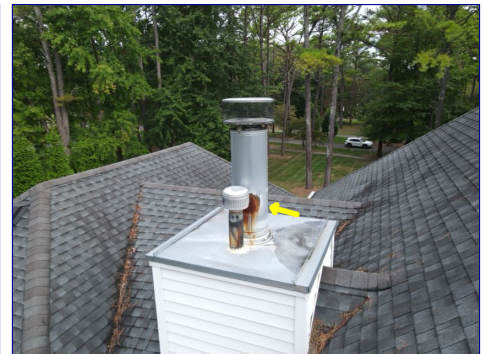
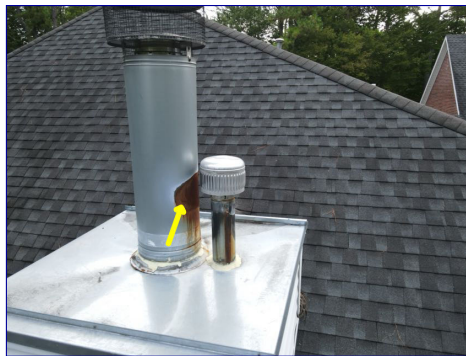
• The outer visible section of the flue for the living room fireplace is rusted but appears to be intact, recommend a qualified contractor to evaluate and repair as needed

Rust

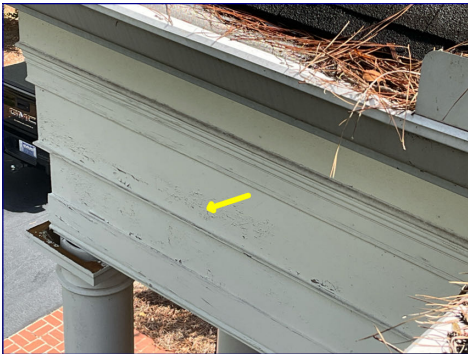
- The brick and mortar siding was cracked and needs maintenance repairs, which may allow moisture damage over time. Recommend a licensed contractor repair.
- There are areas of wood siding where the paint is cracked/flaking and need to be scraped and repainted

Needs to be scraped and repainted

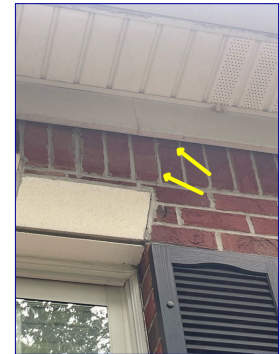
Cracks

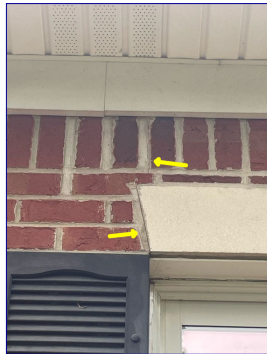
Cracks

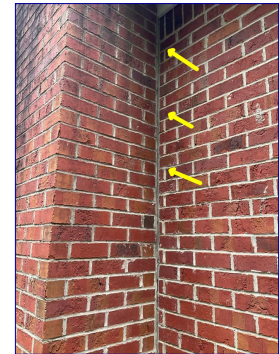
Cracks

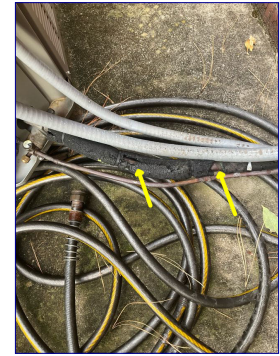
- There is damaged and/or missing insulation on the air conditioner refrigerant line. Recommend replacing insulation.

Damaged refrigerant line insulation

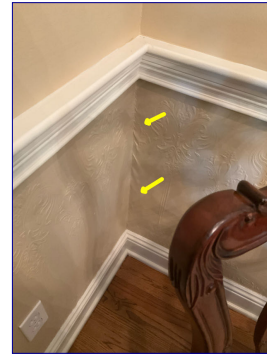
- There are cracks and wrinkled wallpaper noted in the corner of the dining room (pictured) which are signs of settling, recommend further evaluation by qualified contractor and repair if needed

Wrinkled wallpaper

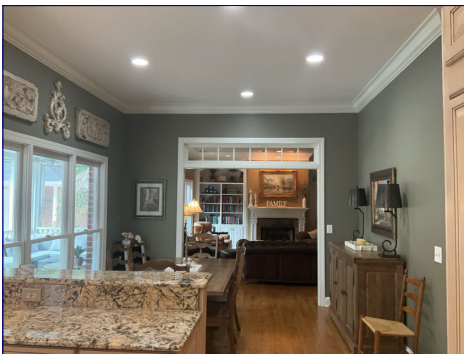
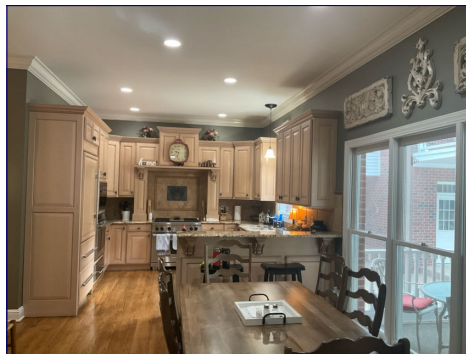
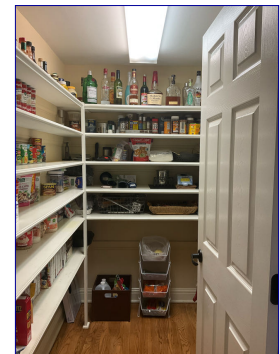
- Typical cracking present in the kitchen walls/ceiling. Recommend monitoring and repair as needed.

Typical crack

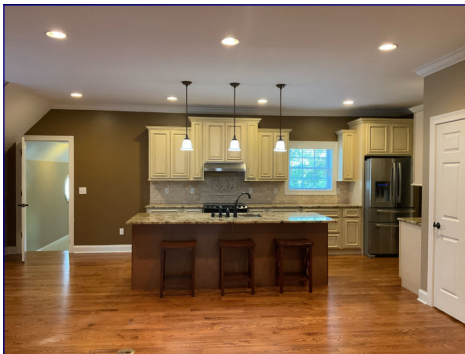
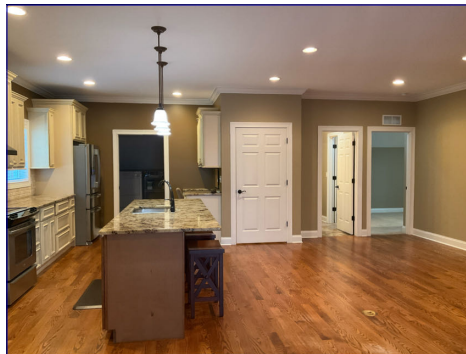
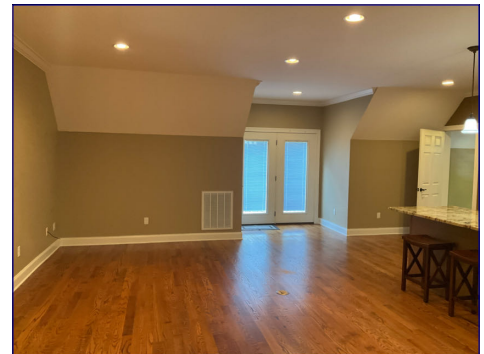
- There are loose tape seams, and settling cracks indicating settling, noted on the SW corner, recommended qualify contractor to evaluate and repair as needed

Loose tape seems and settling cracks

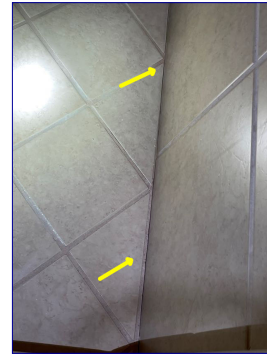
- Recommend caulking/grouting around the shower base to help prevent damage from water penetration.

Needs caulking/sealing

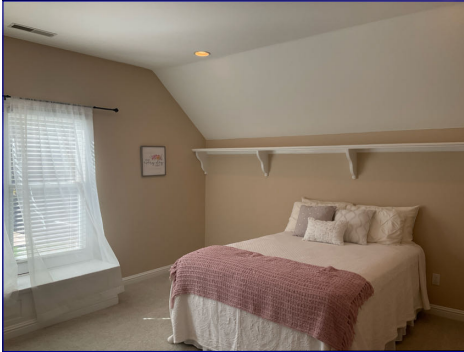
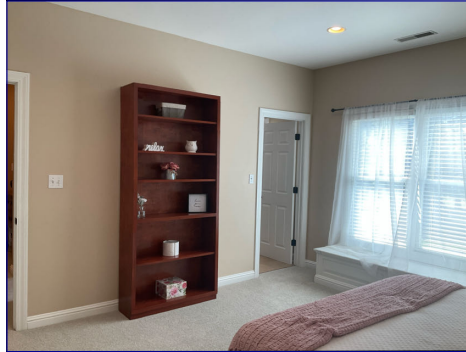
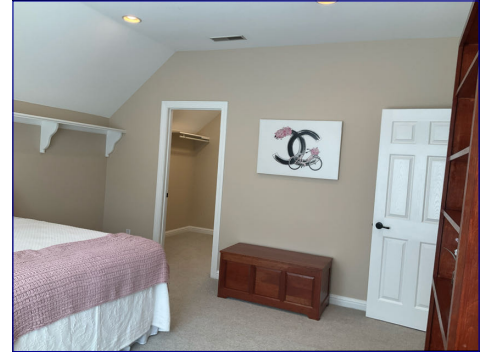
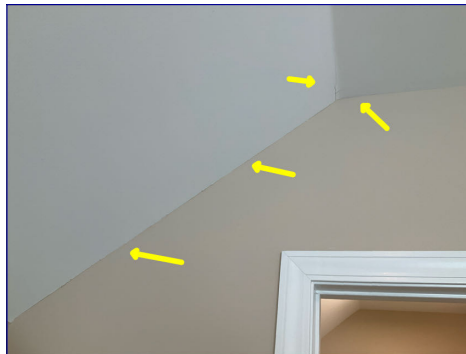
- There are settling cracks on the walls/ceilings. Consult with a professional contractor to repair as needed.

Settling cracks

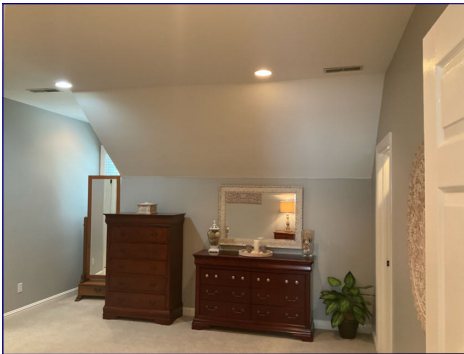
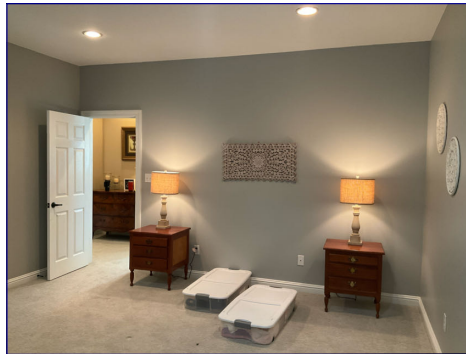
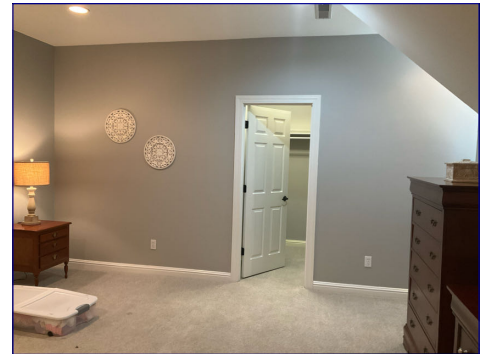
• There are moisture stains/streaking noted on the walls inside the closet, these appear to be caused from excessive moisture, coming from the HVAC unit, recommend the qualified contractor to evaluate further and recommend solutions

Typical crack

Moisture streaks

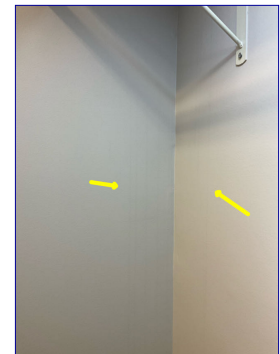
Moisture streaks

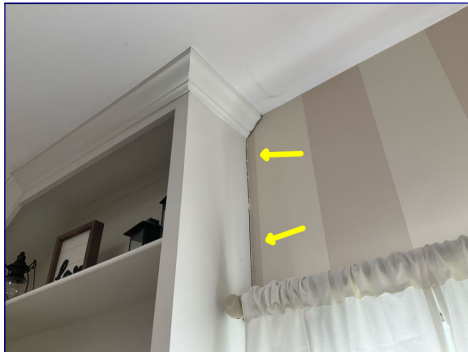
- There are settling cracks on the walls/ceilings. Consult with a professional contractor to repair as needed.

Signs of settling

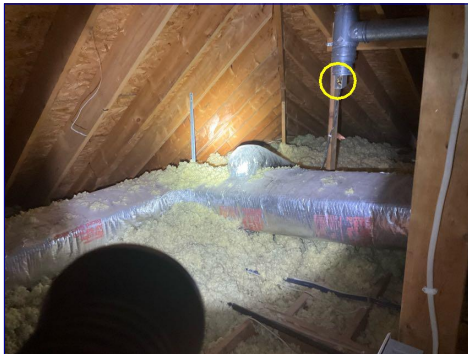
- There is a light switch plate missing in the attic accessible from the closet in the small suite bedroom
- There is at least one open junction box missing its cover in the attic, which is a safety concern. Recommend a licensed electrician install a cover plate.

Open junction box

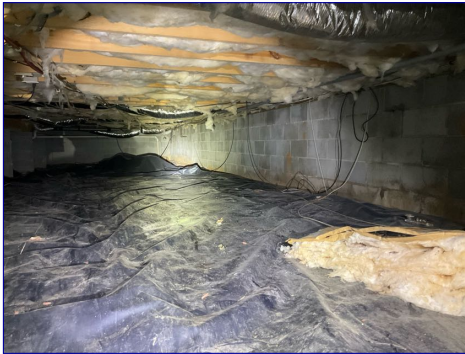
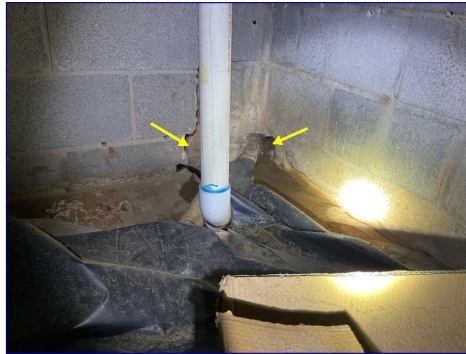
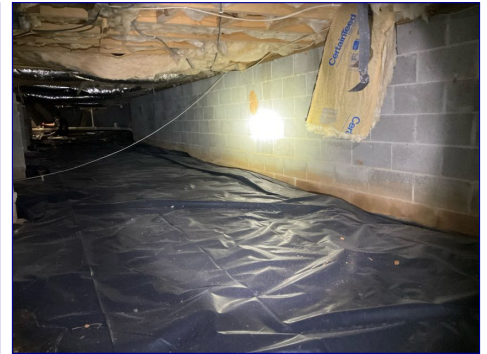
- There are plumbing penetrations through the foundation wall that need to be sealed to prevent moisture and rodent entry

Wall penetrations need to be sealed

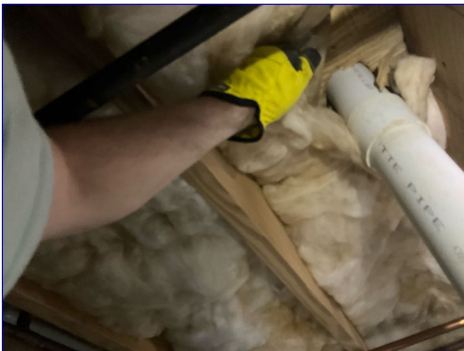
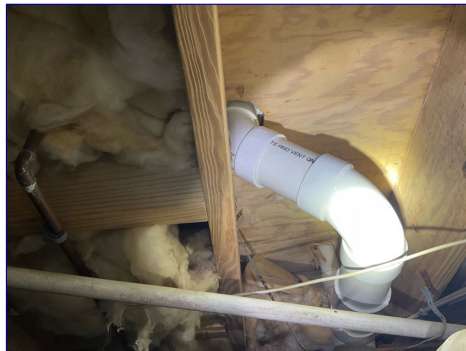
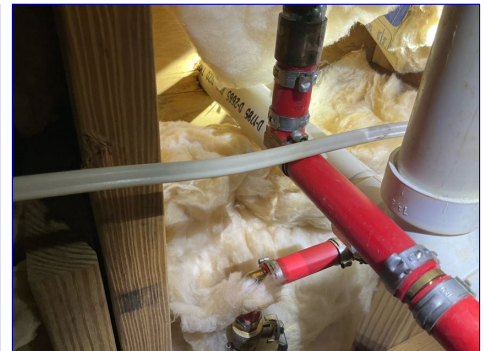
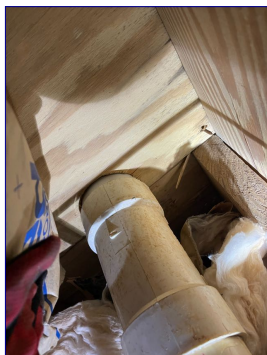
- **There is moisture staining/damage on the subfloor beneath the master shower, I let the shower run for an extended period of time and never did see a leak, recommend a qualified contractor to evaluate and repair as needed**

Moisture stains beneath the master shower
