3804 Central Ave. Nashville, TN

INSPECTION DATE: February 28, 2019

**PREPARED BY: Brent Scott
PREMIER HOME INSPECTION LLC.
6001 Jackson Square Blvd.,
Suite 400
LaVergne, TN. 37086
615-481-7293 (Office)
615-893-6305 (Fax)**

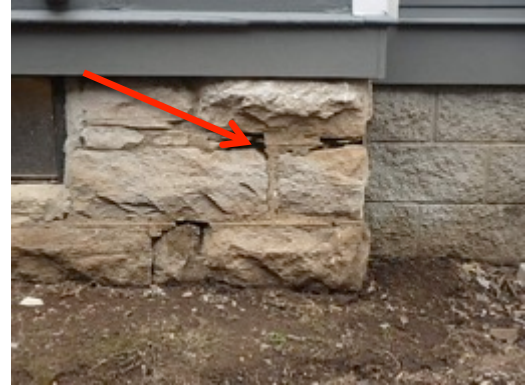
1. Missing grout was noted in several areas of the foundation walls. Corrections are recommended to avoid moisture intrusion and to maintain the stability of the walls. Further investigation is recommended by a qualified professional with corrections made as needed.

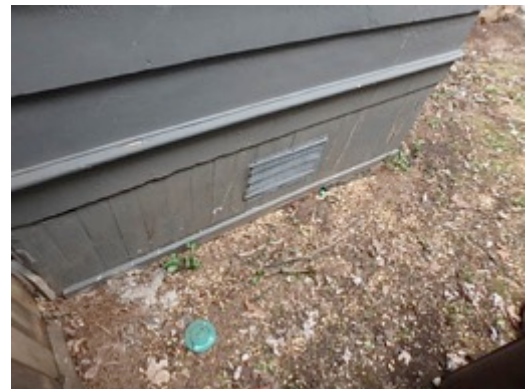
2. Areas of the wood siding are in contact with the earth on the right wall. This can allow moisture damage and moisture and pest intrusion. A 2 inch gap is recommended between the siding and ground.

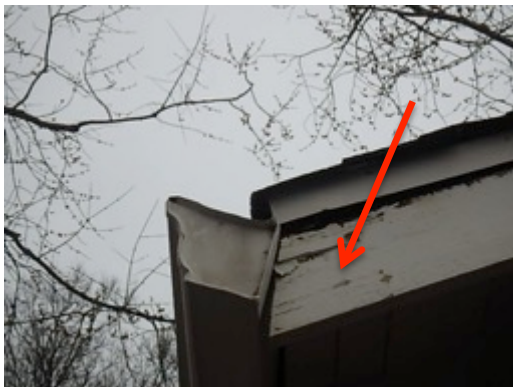
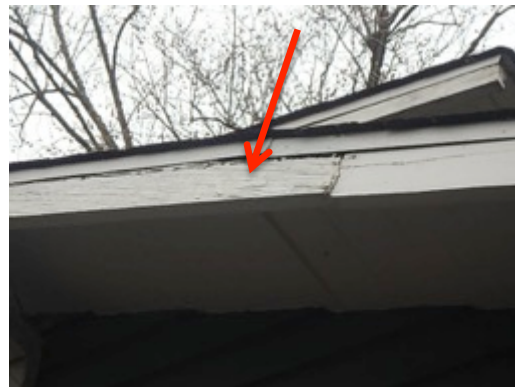
3. Areas of soft wood were noted on the siding and trim on the exterior of the home. Soft wood was noted on the areas of the upstairs windows. Areas of damaged and deteriorated paint were noted on the exterior surfaces. Further investigation is recommended by a qualified professional with corrections made as needed.

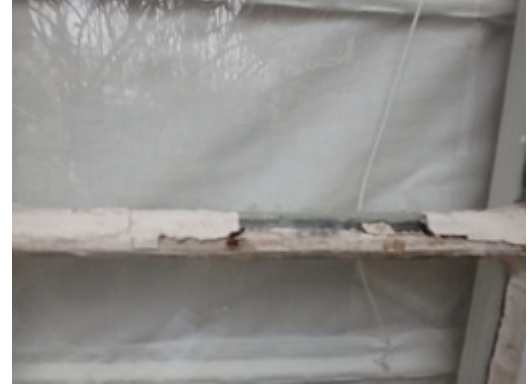
4. Cracked glazing was noted on several windows. The glazing secures the panes in the window sashes. Repairs to the glazing are recommended as needed to prevent moisture intrusion and heat loss.

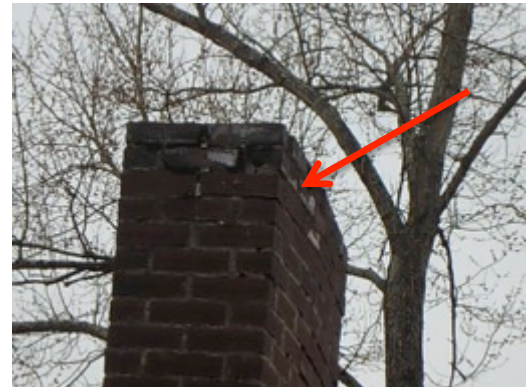
5. Gaps were noted in the brick grout on the chimney. Areas of the chimney walls are bowing. No cap was visible from the eaves on the chimney cap. The fireplace and chimney flue was not accessible for inspection due to storage and a plate in front of the fireplace. Further investigation of the chimney, fireplace and flue is recommended by a licensed contractor and chimney sweep with corrections made as needed.

FIREPLACE/CHIMNEY: The fireplace was not accessible due to storage and a plate on the fireplace opening. A level 2 inspection is recommended by a licensed chimney sweep with corrections made as needed.

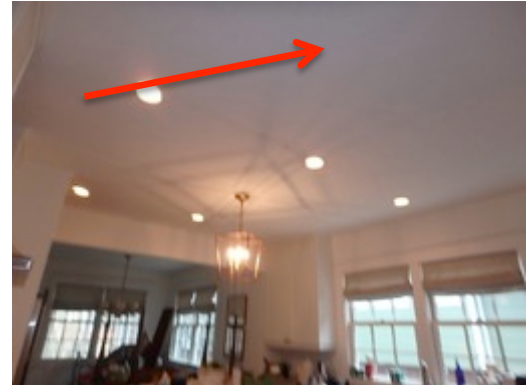
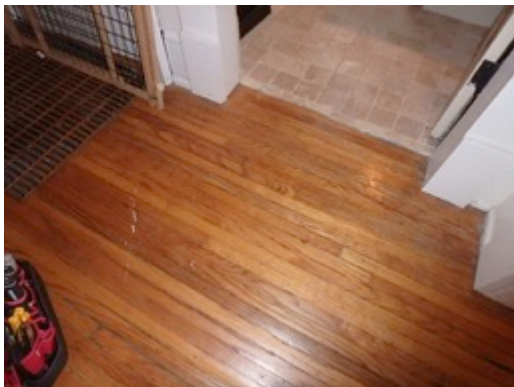
6. Moisture stains were noted on the kitchen ceiling. Further investigation is recommended by a qualified professional with corrections made as needed.

7. Soft flooring was noted in the hallway. Further investigation is recommended by a qualified professional with corrections made as needed.

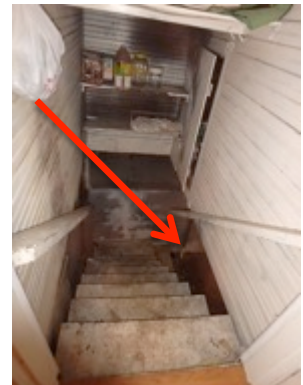
8. Proper balusters should be installed on the stairwell leading to the basement to maintain safety.

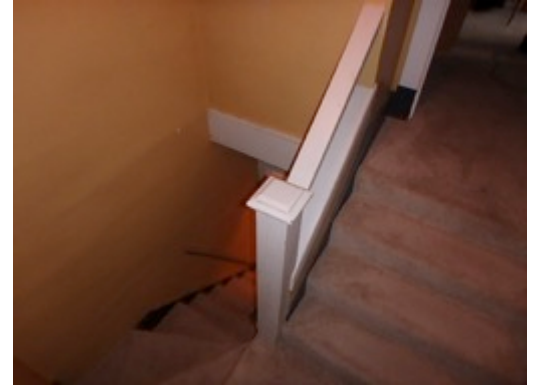
10. It is recommended to install a graspable handrail the entirety of the upstairs stairwell to maintain safety.

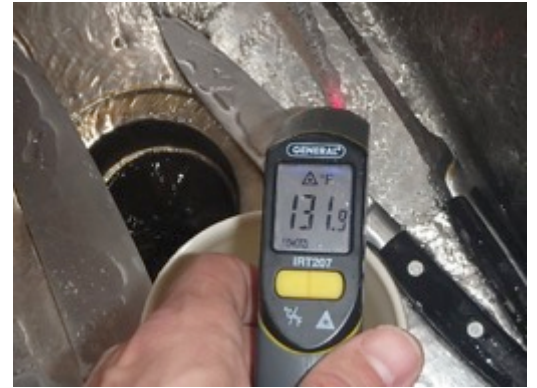
13. The hot water temperature was 131 degrees F at time of inspection. It is recommended that the thermostat on the water heater be adjusted to obtain a hot water temperature between 100 and 120 degrees F to prevent scalding.

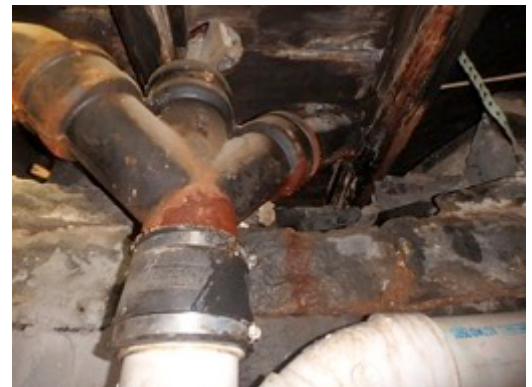
16. A leak was noted below the downstairs bathroom. Possible damage was noted to the flooring system. Further investigation is recommended by a licensed contractor with corrections made as needed.

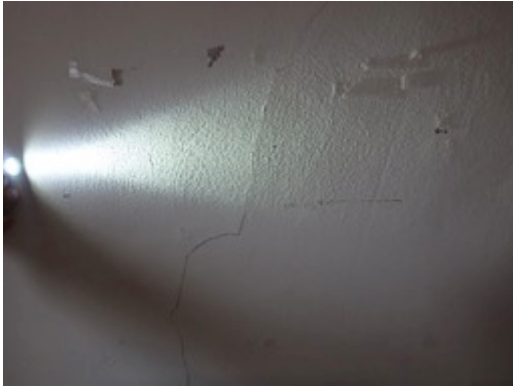
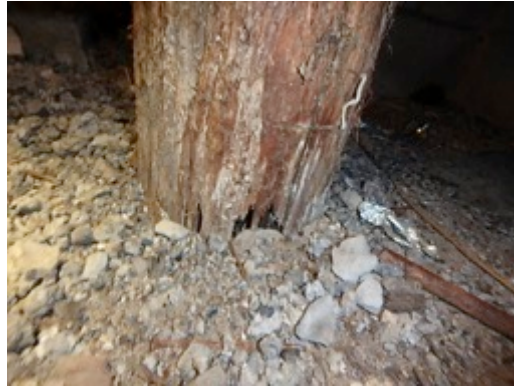
17. Cracking and heaving was noted in the front porch. Uneven flooring was noted throughout the home. Areas of cracking were noted in the wall and ceiling finishes. Deflection was noted in the roof structure. Damage was noted on the wood support posts in the basement. Further investigation of the home is recommended by a structural engineer with corrections made as needed.

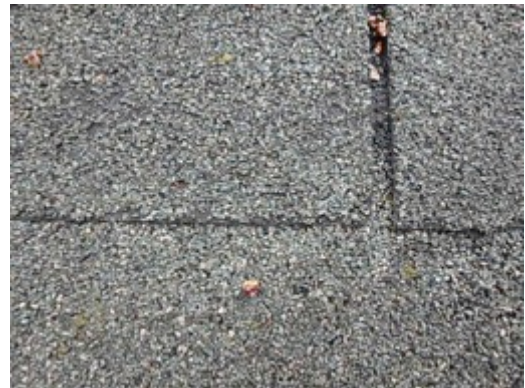
18. The front part of the roof appears to be older than the rear over the addition and rear porch. Pitting and blistering was noted on the older parts of the roof. Lifted shingles were noted on the older parts of the roof. Evidence of leaks was noted. An apparent moisture stain was noted over the upstairs bathroom sink. Further investigation of the roof and components is recommended by a licensed roofing contractor with corrections made as needed.

ROOF COVERING: The roof is covered with composite asphalt and fiberglass shingles. The front part of the roof appears to be older than the rear over the addition and rear porch. Pitting and blistering was noted on the older parts of the roof. Lifted shingles were noted on the older parts of the roof. Evidence of leaks were noted. Further investigation of the roof and components is recommended by a licensed roofing contractor with corrections made as needed.

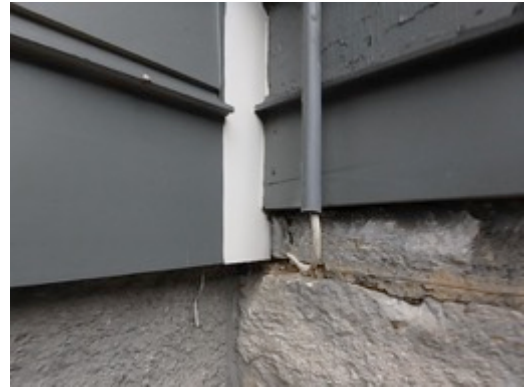
19. An improper wire penetration was noted below an outlet on the left wall. A complete conduit with connector is recommended where wires penetrate walls to avoid damage to the wire sheathing. Further investigation is recommended by a licensed electrical contractor with corrections made as needed.

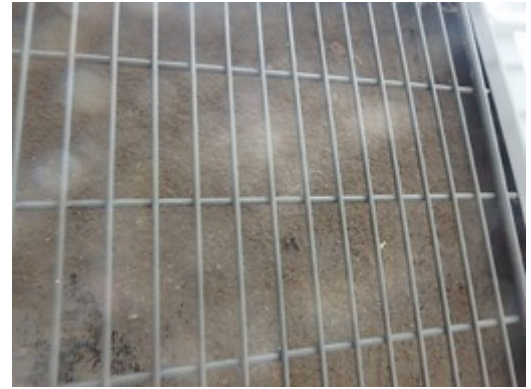
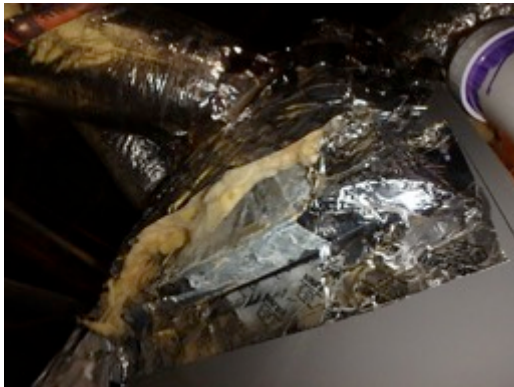
23. Dirty coil fins were noted on the HVAC units. It is recommended to have the units inspected, serviced and repaired as needed by a licensed HVAC contractor.

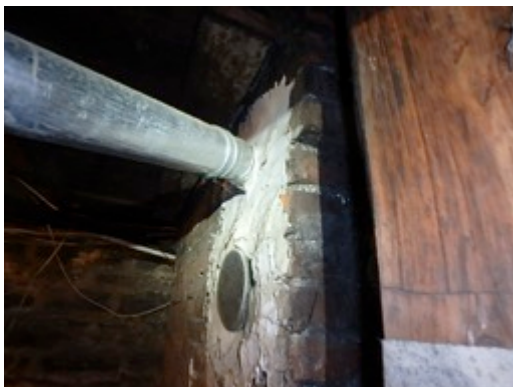
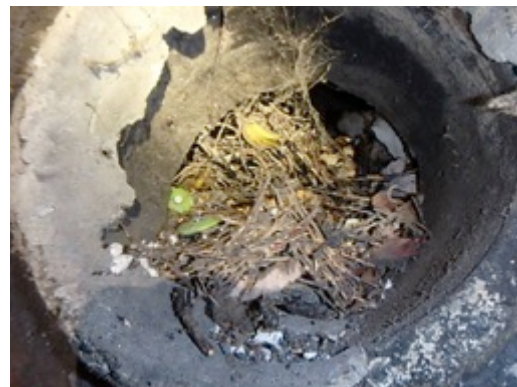
25. The exhaust flue on the water heater is terminating into the chimney flue. There is an opening on the side of the chimney in the basement. Combustible material was noted in the opening. This is a fire and carbon monoxide hazard and should be corrected immediately by a licensed HVAC contractor.

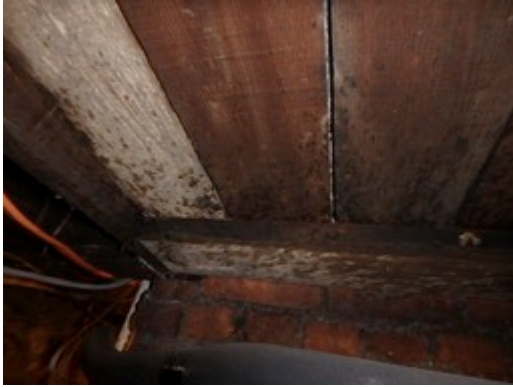
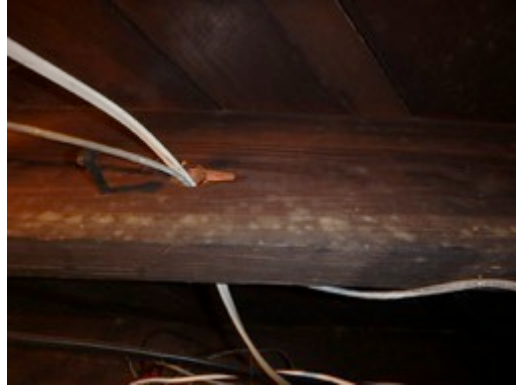
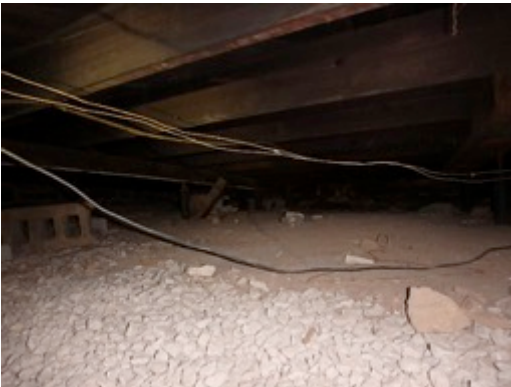
26. Apparent fungal growth was noted in several areas of the crawlspace. Further investigation is recommended by a qualified specialist with corrections made as needed.
