## Home Inspection Report

PROPERTY INSPECTED:  
9427 Creighton Drive  
Powell, OH 43065

Date of Inspection: 05/11/2021

Inspection No. 241387-452

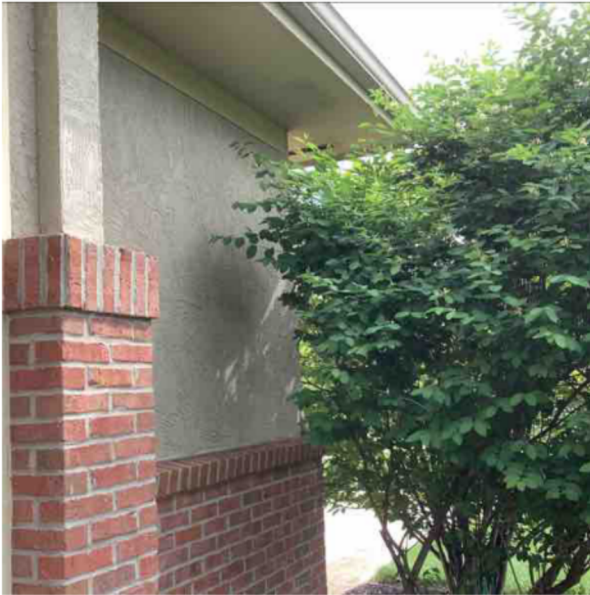
1.1.1 Trim and maintain trees, bushes and vines away from the structure to minimize damage/wear to structure and to discourage animal activity. **(Exterior Left)**

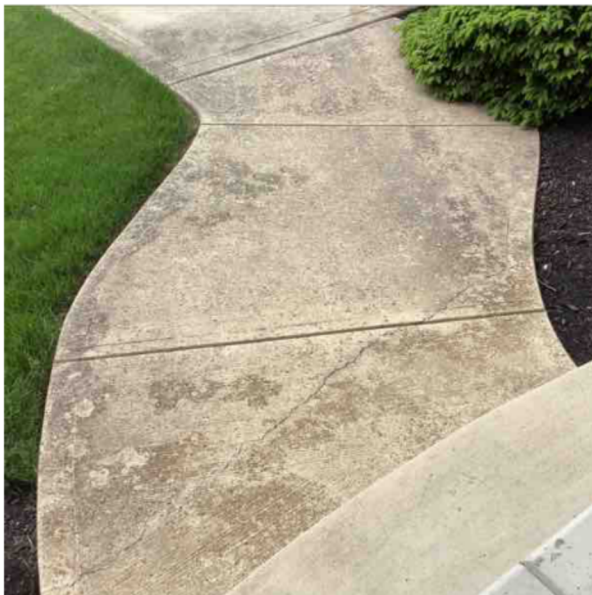
1.2.1 Typical minor cracks in walkway. No improvements are necessary at this time. **(Exterior Front)**

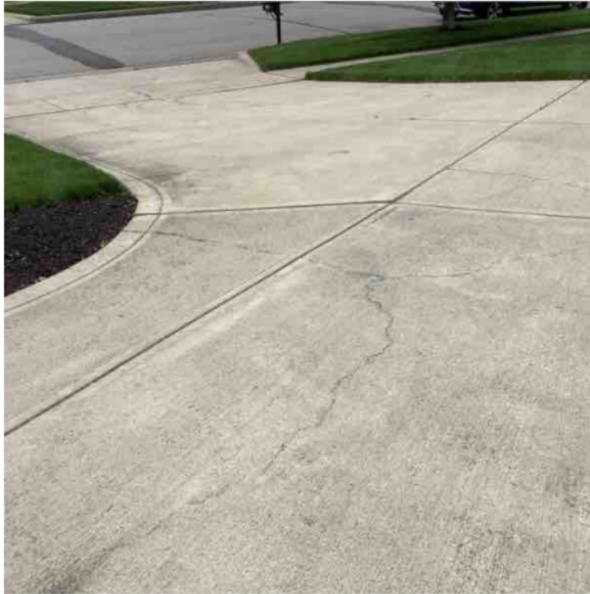
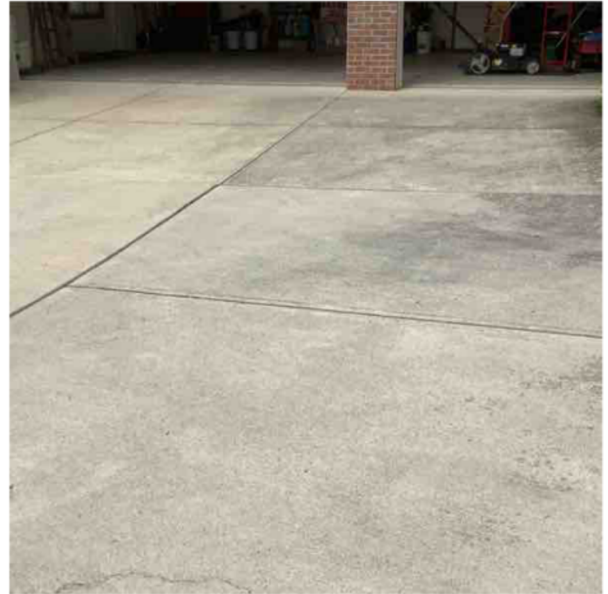
1.3.1 The driveway shows typical and minor surface wear and cracking. Periodic maintenance may prolong the life of the surface. (Exterior Front)

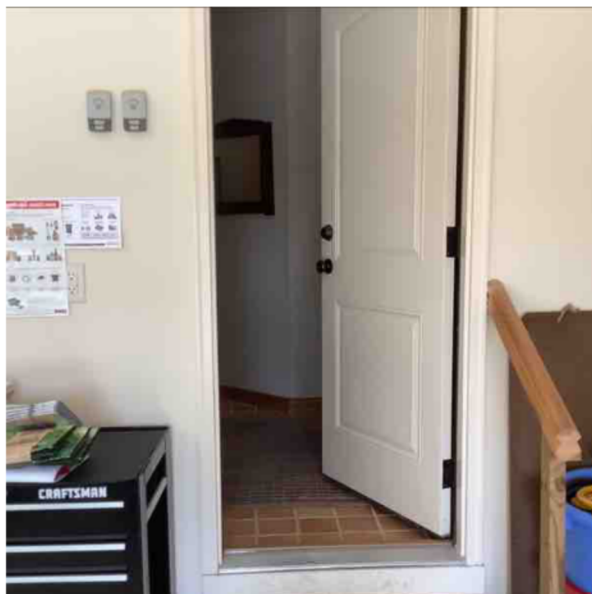
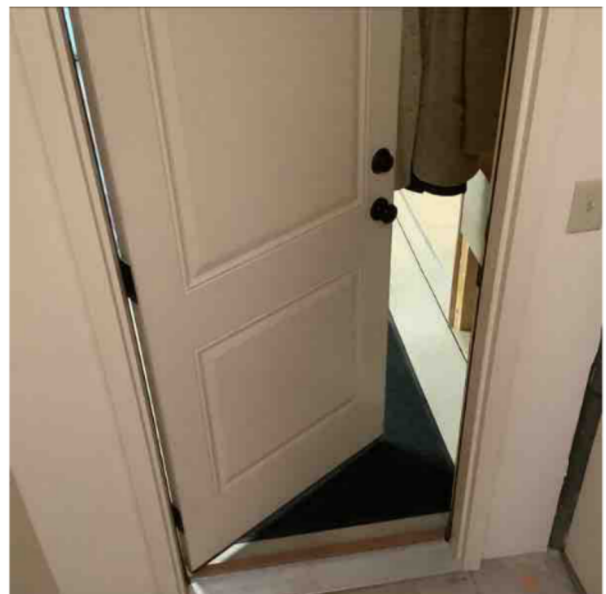
5.1.1 The garage access doors do not have an automatic closing mechanism. Recommend installing one for fire/gas barrier safety. **(Garage)**

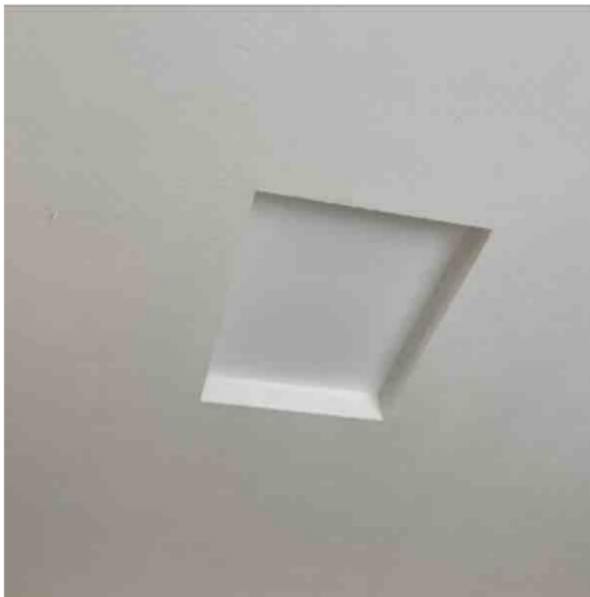
5.4.1 The attic hatch is painted shut.

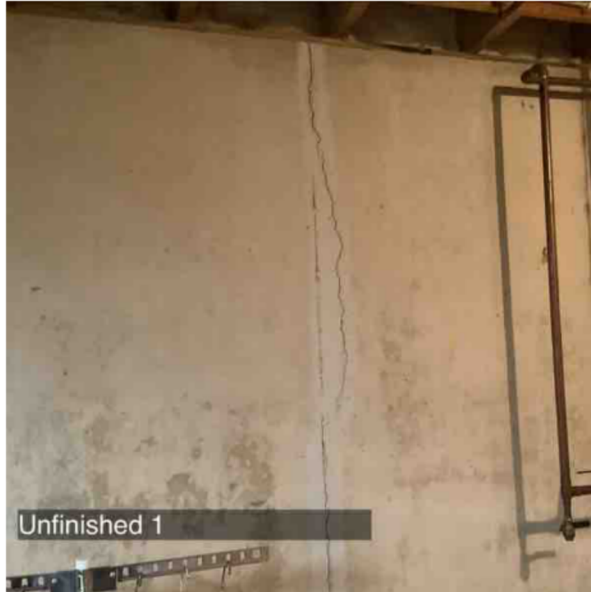
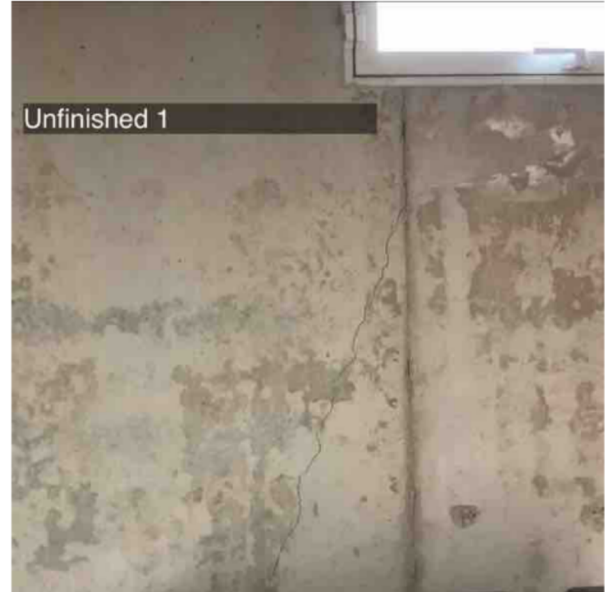
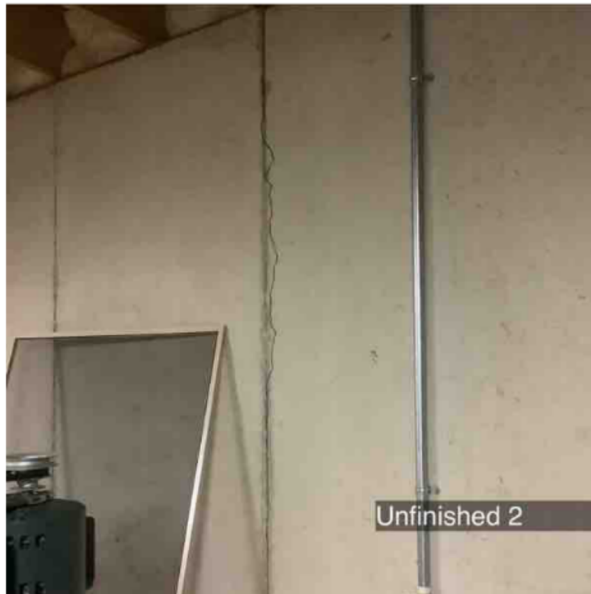
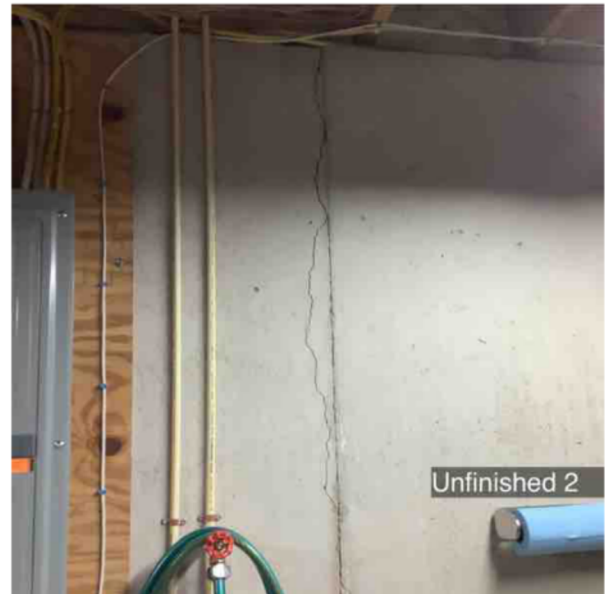
6.1.1 Typical minor cracks were noted. No action is considered necessary at this time, however any crack should be monitored for future movement.

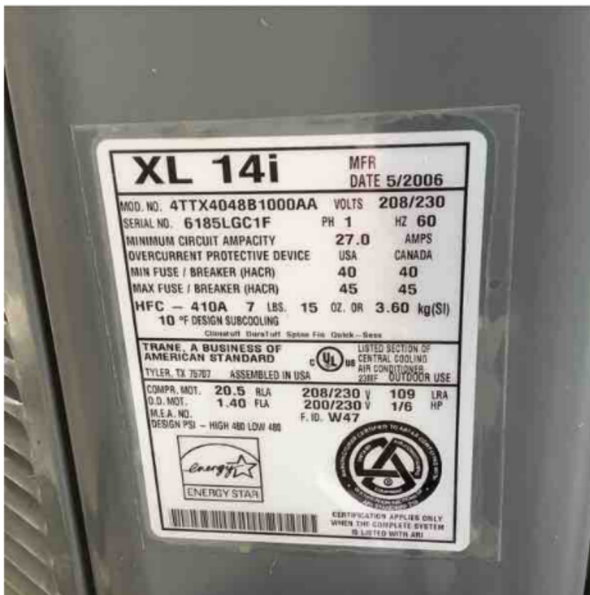
8.2.1 Current unit is past the middle of it's typical life expectancy. Budget to replace when unit fails or is no longer cost effective to repair.2006

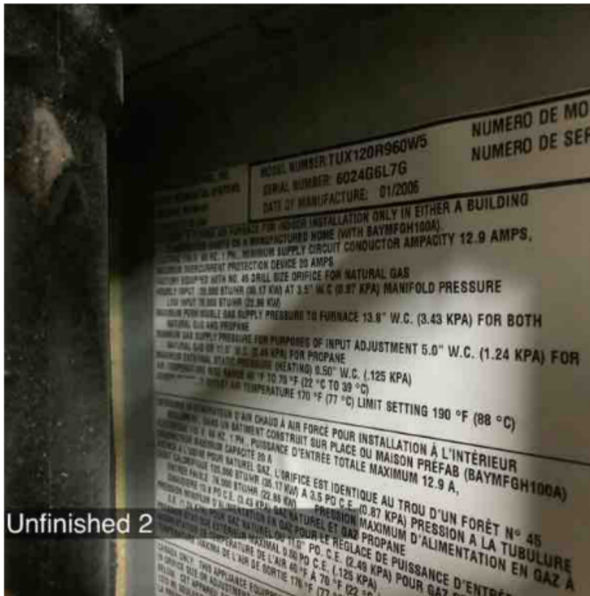
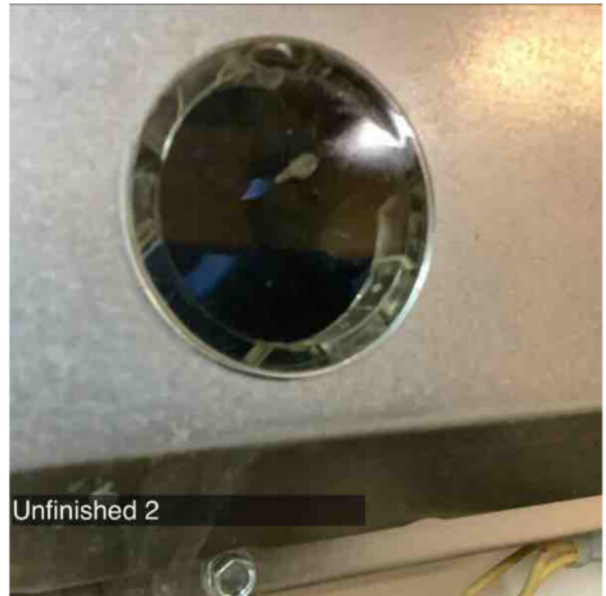
8.3.1 The furnace is in the middle of its typical service life. The remaining life is unpredictable. Replace the unit when it fails, when repairs are no longer cost-effective, or proactively to prevent a loss of functionality.2006 (**Unfinished Basement 2**)

8.3.1 The furnace is in the middle of its typical service life. The remaining life is unpredictable. Replace the unit when it fails, when repairs are no longer cost-effective, or proactively to prevent a loss of functionality.2006 (Unfinished Basement 2)

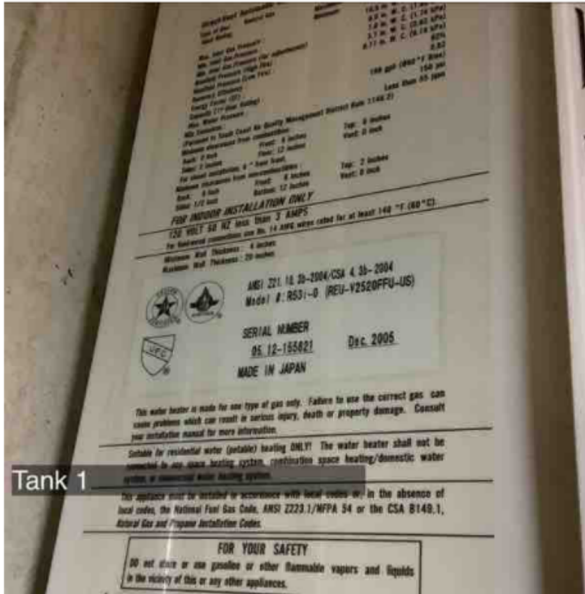
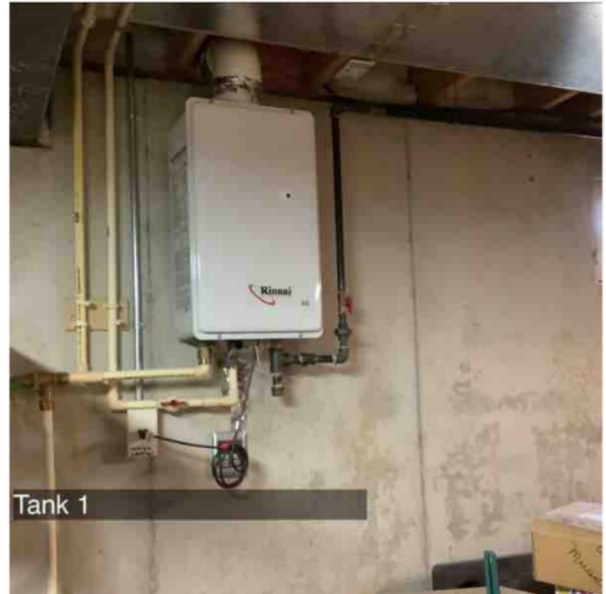
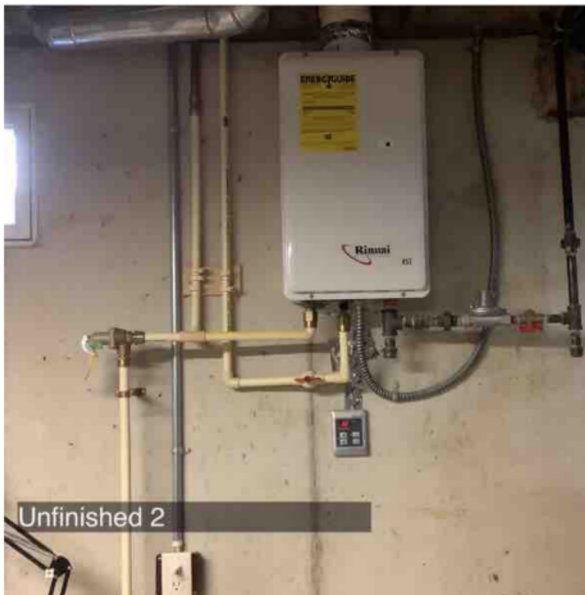
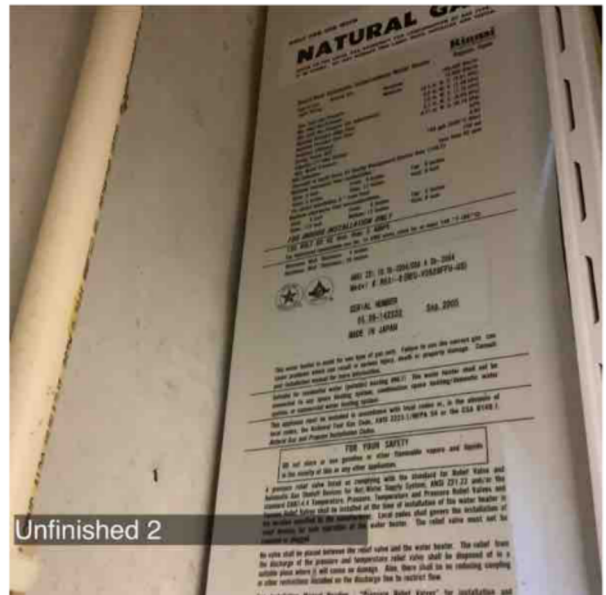
9.4.1 Both water heaters are passed the middle of its typical service life. The remaining life is unpredictable replace the units when it fails, when repairs are no longer cost effective, or proactively to prevent a loss of functionality.2005

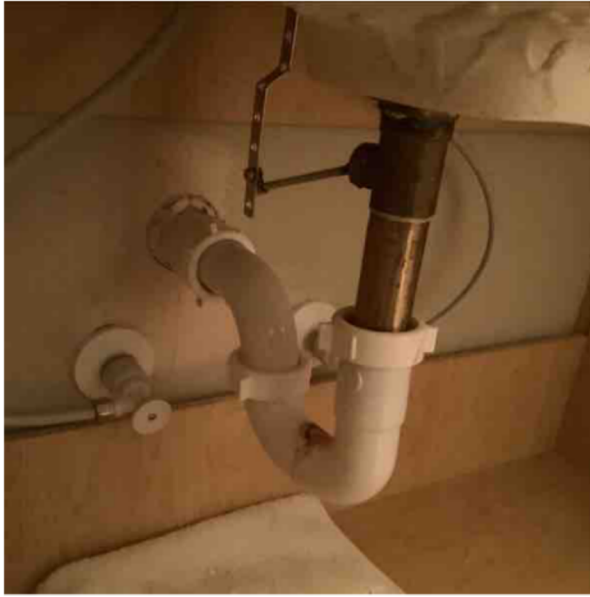
9.5.1 The sink shows signs of a previous leak. There was no leak at the time of inspection. Recommend monitoring for future leaks and repaired or replace as needed. (Hallway Bathroom 1st Floor)

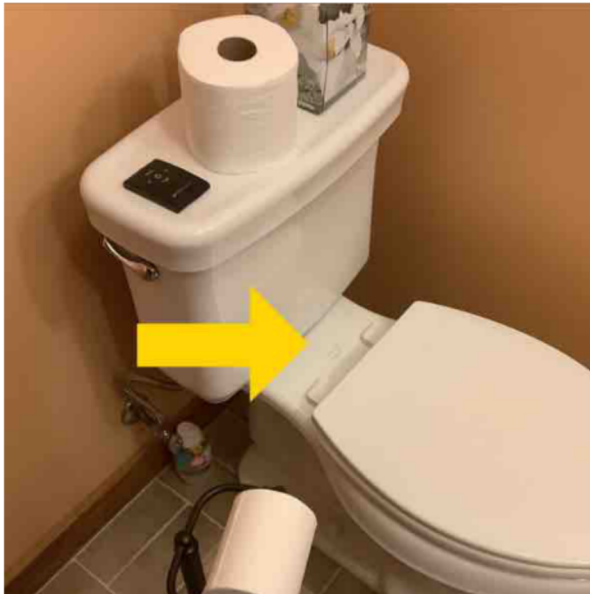
9.6.1 The toilet is leaking. Repair or replace it to prevent water damage. (**Basement Half Bathroom**)

9.6.1 The toilet is leaking. Repair or replace it to prevent water damage. (Basement Half Bathroom)

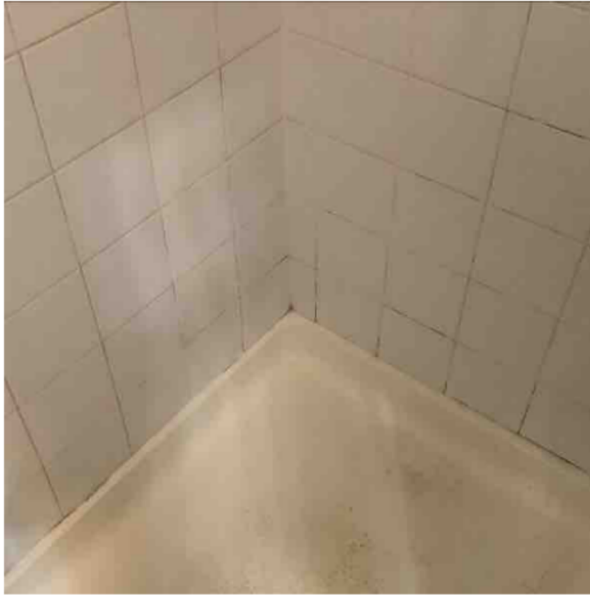
9.7.1 General grout and caulking repairs are required. This should be done soon to minimize leakage and further damage. **(Master Bathroom)**

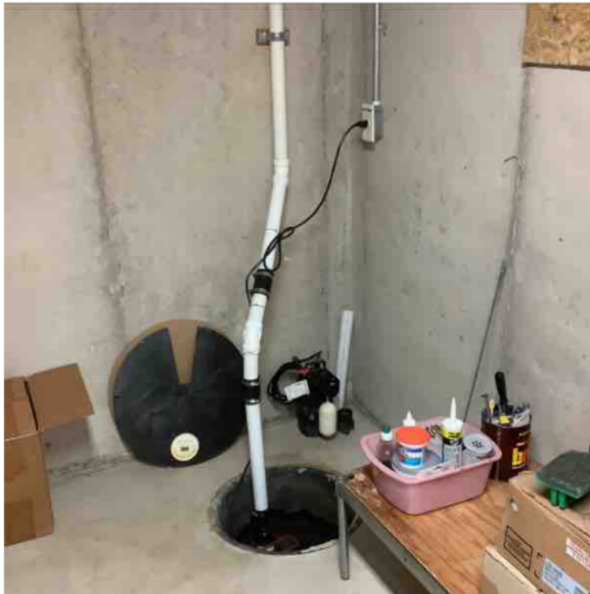
9.8.1 Recommend adding a battery backup to maintain the systems functionality during a power failure.

Tested and operational at the time of inspection. **(Unfinished Basement 2)**

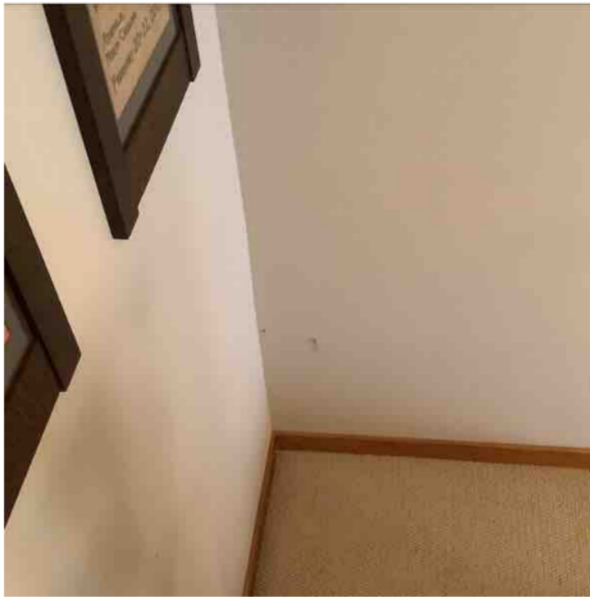
10.1.1 There is damage to the wall. Recommend having this fixed as needed. (Loft)

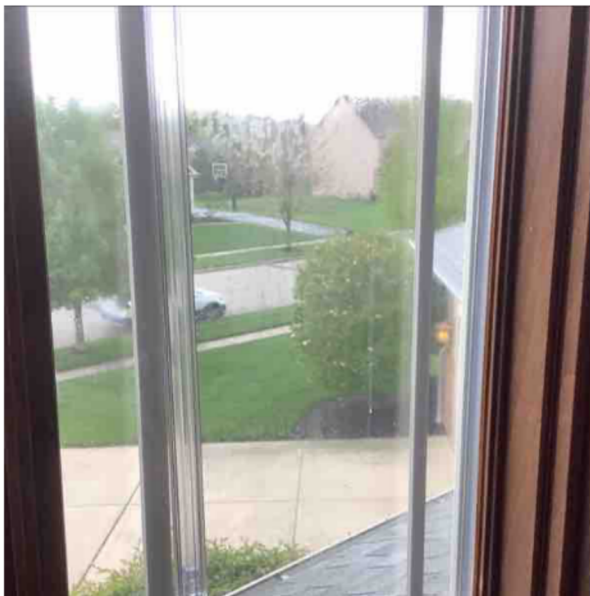
10.2.1 The window seal is broken. Recommend having this fixed for proper functionality. (Loft)
