HOME INSPECTION REPORT

On Monday, July 5, 2021 The HomeTeam Inspection Service made a visual inspection of 3465 Saigon Dr, Westerville, OH 43081. Enclosed please find a written, narrative report of our findings in accordance with the terms of our Inspection Agreement.

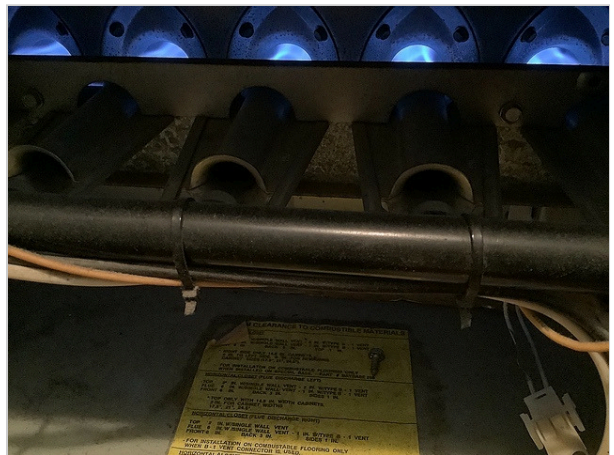
Photo 60

The furnace may be past its design life. This is an informational note only to help give an idea of future budgeting considerations. The system was functional at the time of the inspection unless noted otherwise. Please note that since codes change, it is possible the configuration for the flue and/or condensate lines may need to be altered at the time of a future replacement.

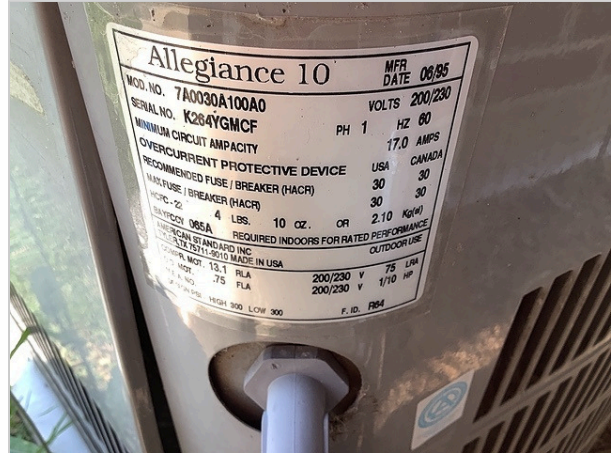
Photo 62

The air conditioner may be past its design life. Unless noted otherwise, the system was functional at the time of the inspection. As with a light bulb that functions normally one day but the next may not turn on, a system's age is a helpful factor that assists in budgeting for eventual replacement.

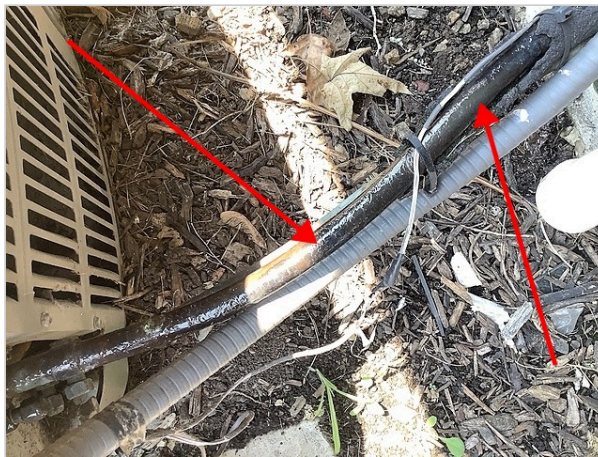
Photo 63

The insulation on the exterior air conditioning line set is missing. This could affect the efficiency of the system and should be replaced.

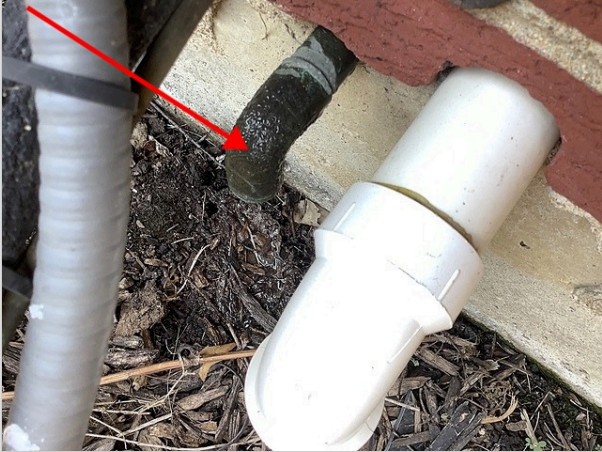
Photo 64

The condensate line for the HVAC system is discharging adjacent to the foundation. Condensate water is mildly corrosive and can cause damage to the foundation over time. The condensate drain line should be extended further away from the structure.
