## Stucco Evaluation Report

**Property Address:**  
200 Country Club Drive  
Telford PA 18969

<b>Date:</b> 4/2/2015	<b>Time:</b> 01:30 PM	<b>Report ID:</b> 1420151
<b>Property:</b> 200 Country Club Drive Telford PA 18969	<b>Customer:</b> Vira Myers	<b>Real Estate Professional:</b> Mary Beth Allen BHHS Fox Roach Realtors

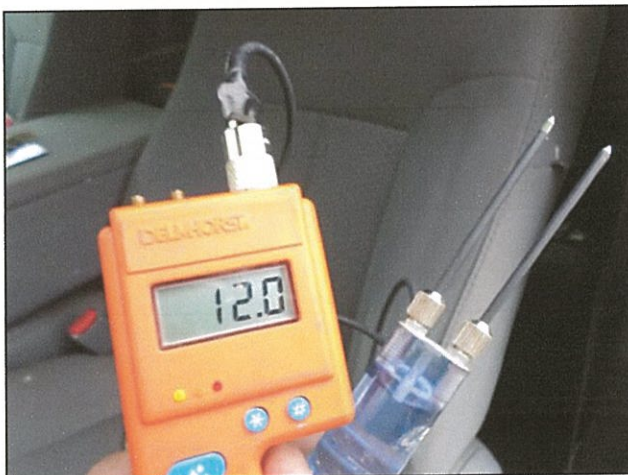
2.0 Item 1(Picture) Moisture meter was calibrated prior to use and after every 2nd reading. Probe tips are teflon coated and protected with shrink wrap to reduce the risk of outside interference

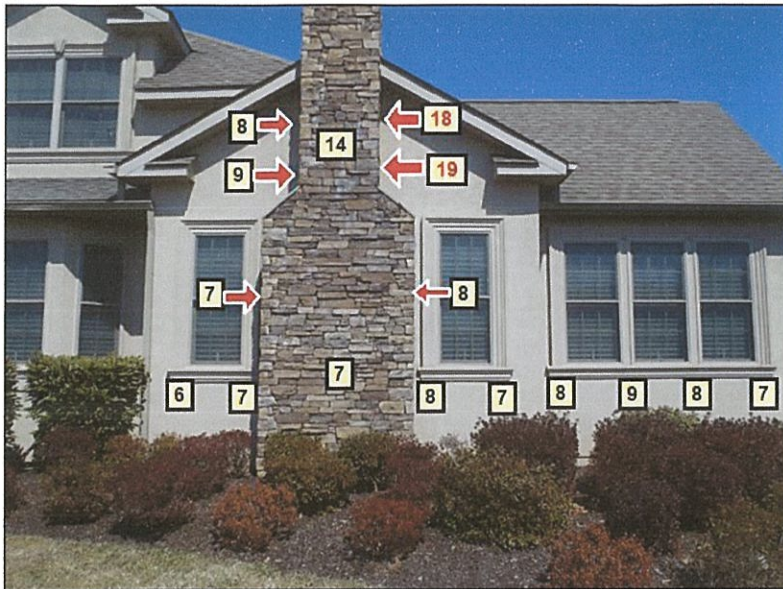
The front elevation was broken into several sections to allow for a better understanding of moisture readings and the locations they were taken from. The right side of the chimney had some loose veneer and only slightly elevated moisture readings. The substrate on the chimney was firm in all areas tested.

2.1 Item 1(Picture) Right front moisture readings

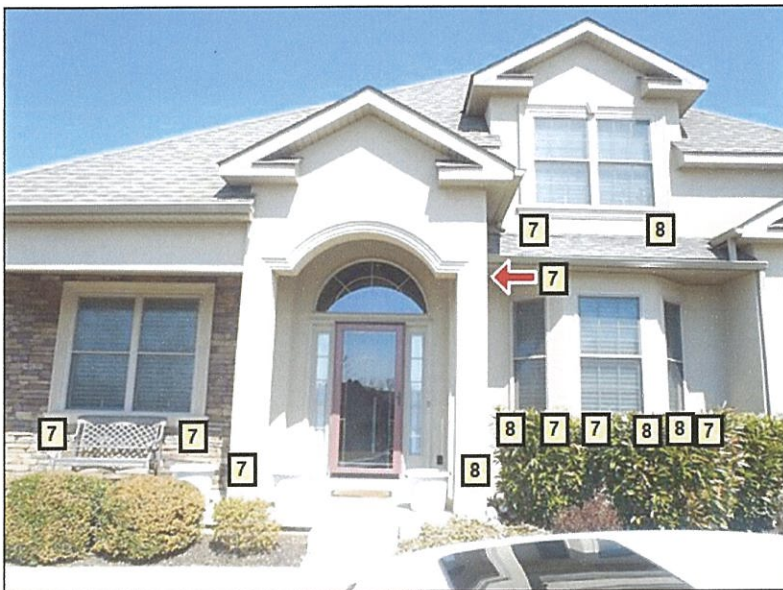
2.1 Item 2(Picture) Left front moisture readings

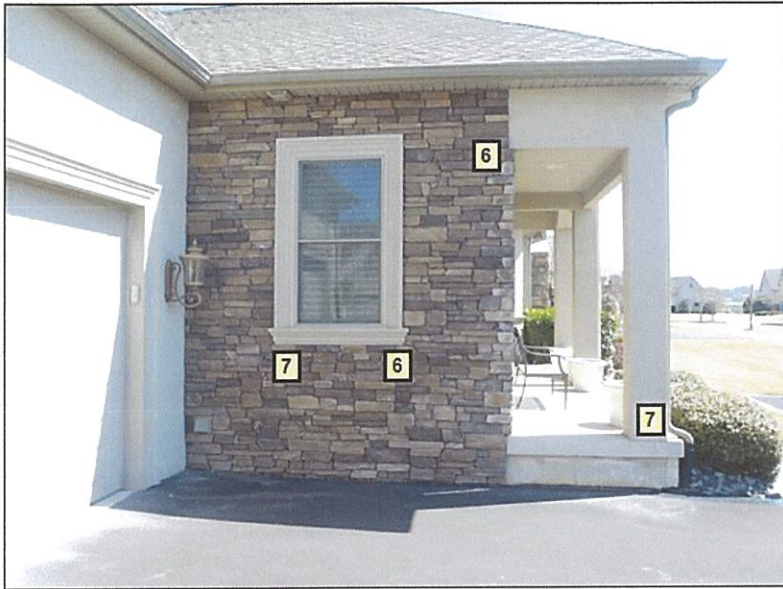
2.1 Item 3(Picture) Left side of front porch, efflorescence noted on veneer

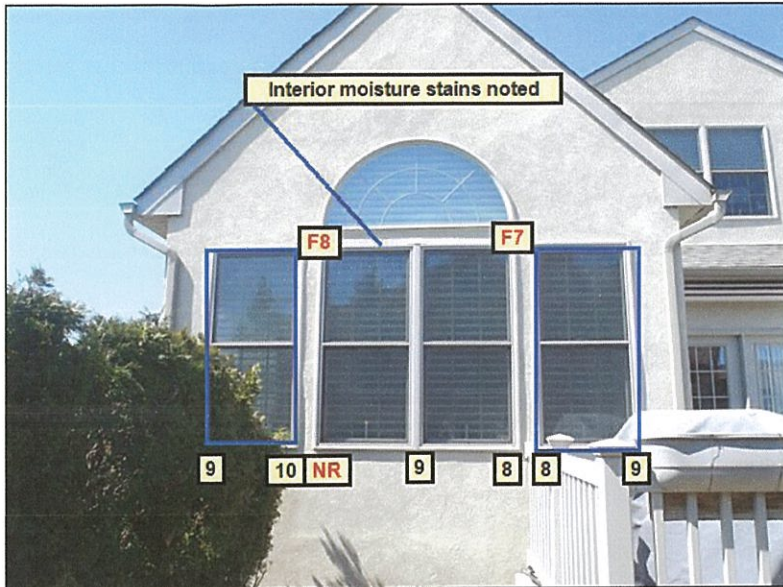
The right elevation recorded elevated and NR moisture readings. NR (no resistance to substrate) and F (framing member) are an indication that sufficient water has penetrated the system and deteriorated the substrate between the stucco system and the framing members of the home.

2.2 Item 1(Picture) Right elevation sunroom windows

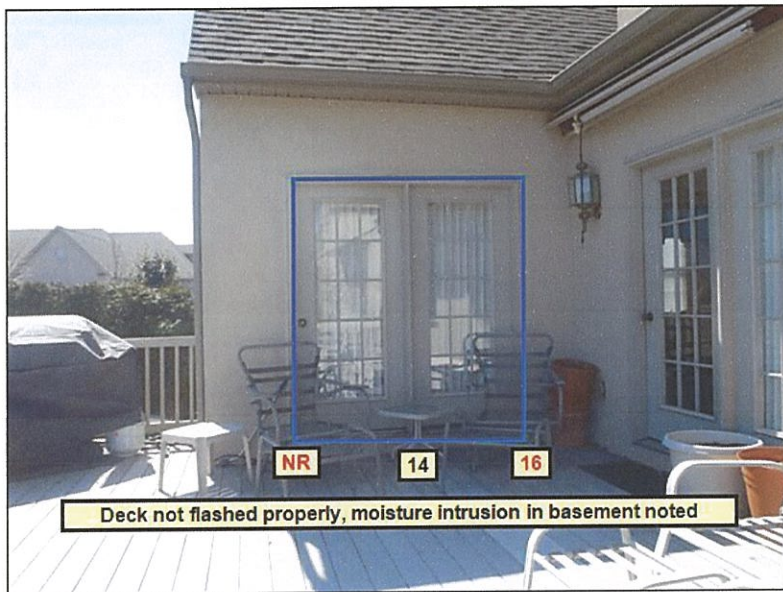
2.2 Item 2(Picture) Doorway to sunroom

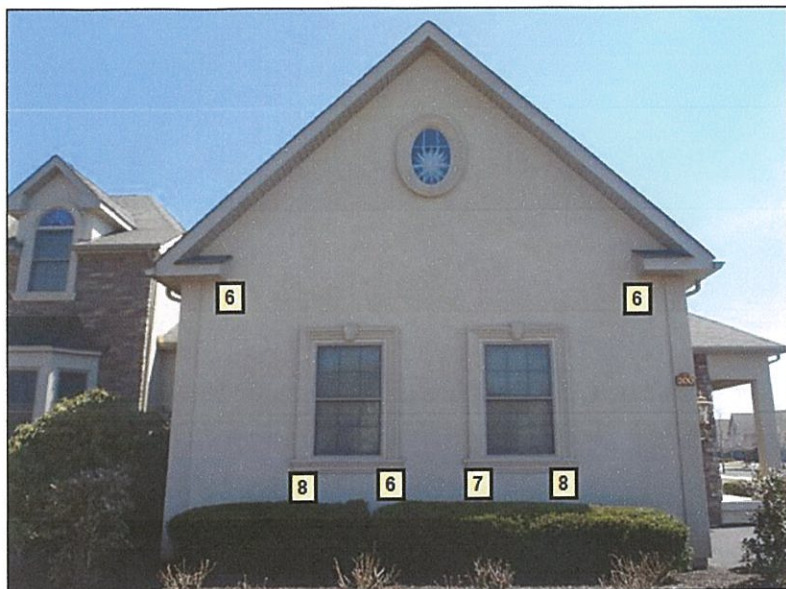
The left elevation was the side of the garage and the rear window behind the garage for the first floor bath. No elevated moisture readings were recorded on these locations.

2.3 Item 1(Picture) Left elevation garage moisture readings

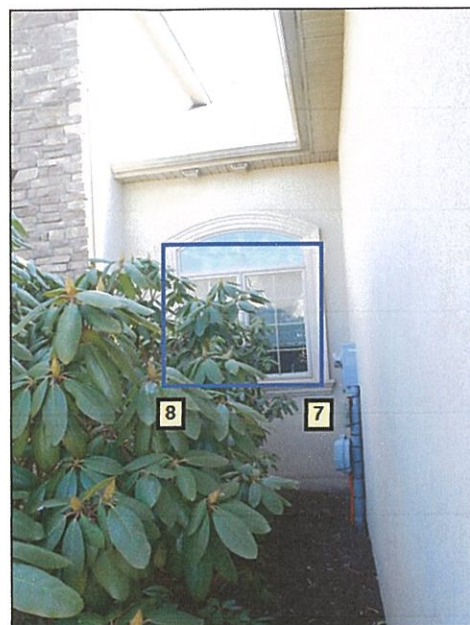
2.3 Item 2(Picture) Rear bathroom window b moisture readings behind garage

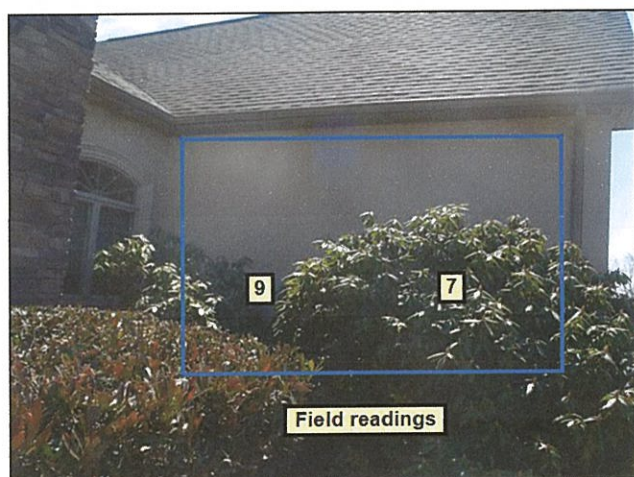
2.3 Item 3(Picture) Rear garage wall, no major penetrations, field readings taken

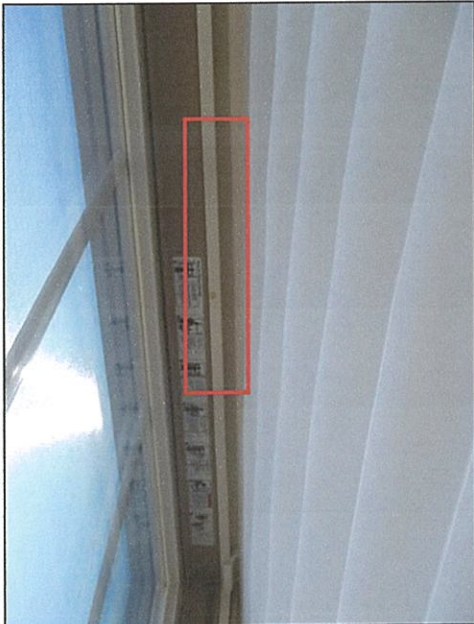
3.0 Item 1(Picture) Moisture stains on interior window under eyebrow window in sunroom

Comments: Yes

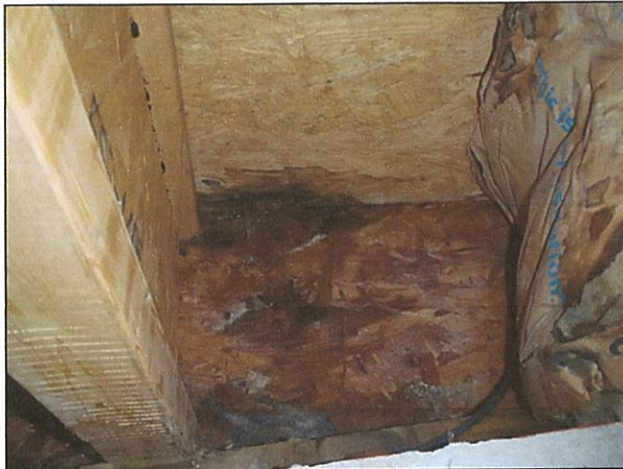
3.0 Item 2(Picture) Moisture intrusion under sunroom doors in basement box beam

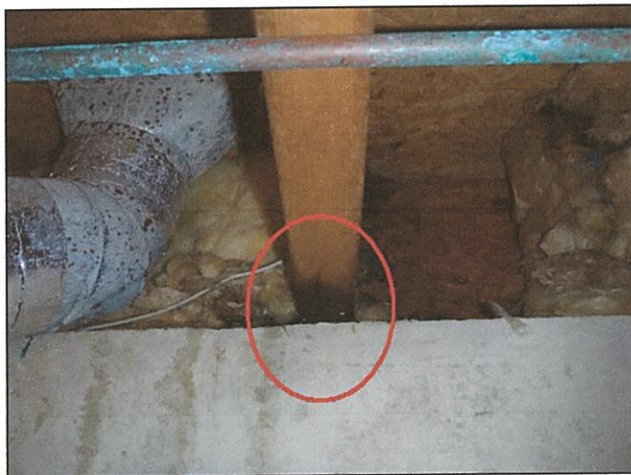
3.0 Item 3(Picture) Moisture intrusion noted on TGI in basement under sunroom entry

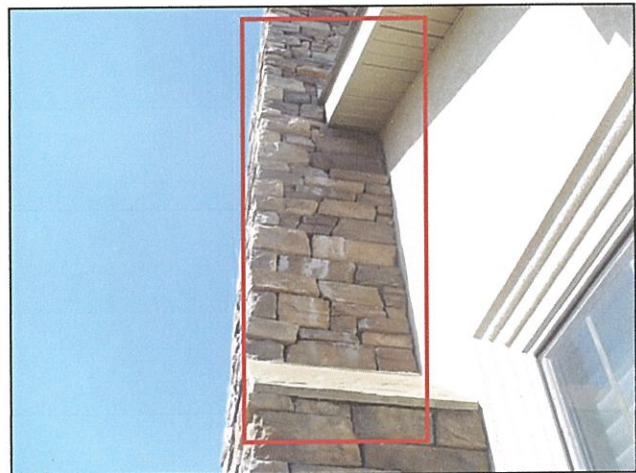
3.0 Item 4(Picture) Efflorescence noted on dry stack veneer, some stone were loose

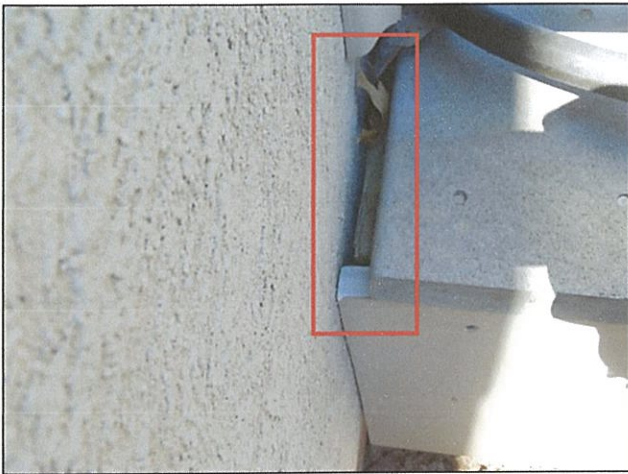
3.0 Item 5(Picture) No Z flashing noted on deck stringer board

**Comments:** Not adequate

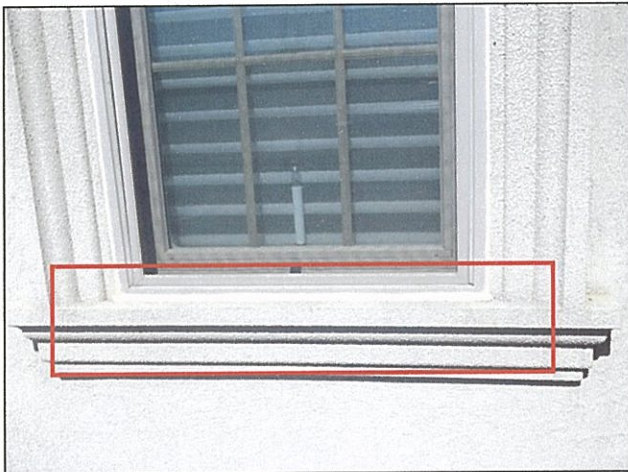
3.0 Item 7(Picture) No flashing details noted on foam trim bands on windows. All have been caulked

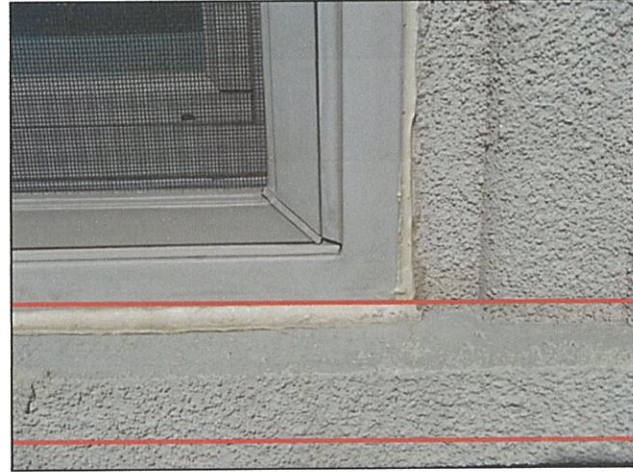
3.0 Item 8(Picture) Finish coat on foam trim bands has deteriorated on front first floor windows

Comments: Damage Noted

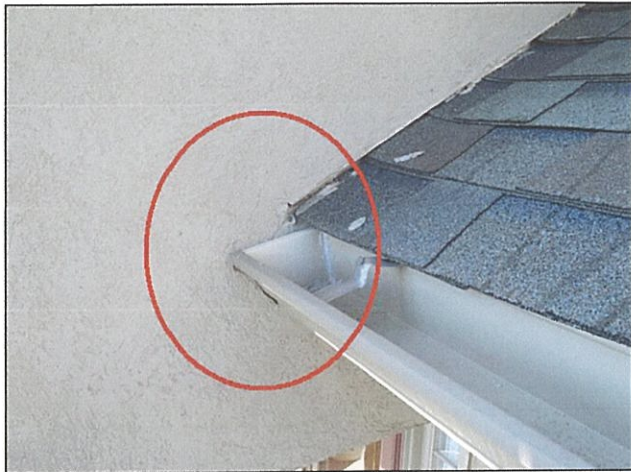
3.0 Item 9(Picture) No kickout flashing installed at roof/wall intersection to right of main front entry. Moisture reading below was 7%

Comments: NO

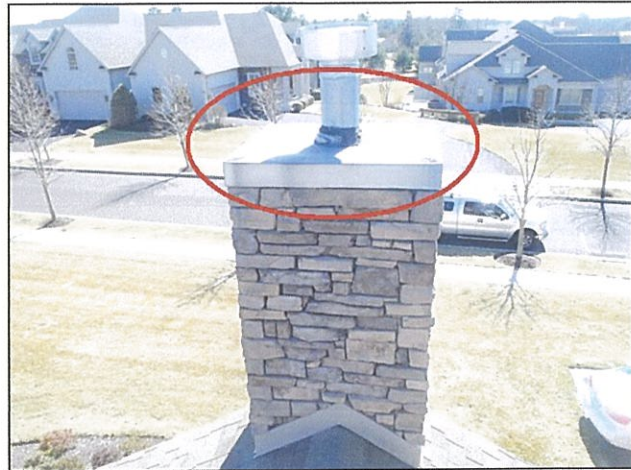
3.0 Item 10(Picture) Chimney cap was in good condition

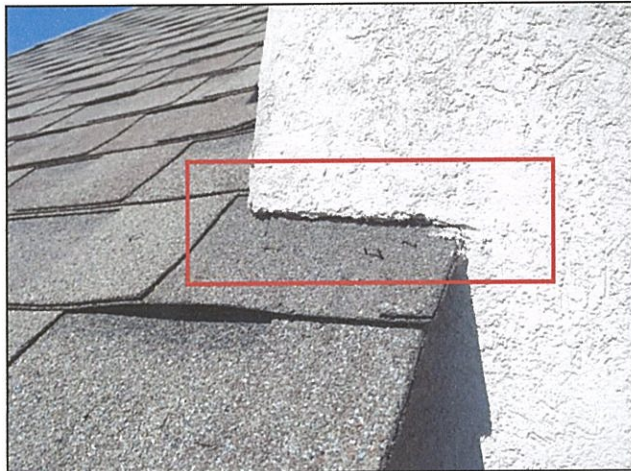
3.0 Item 11(Picture) Stucco in contact with shingles

Comments: NO

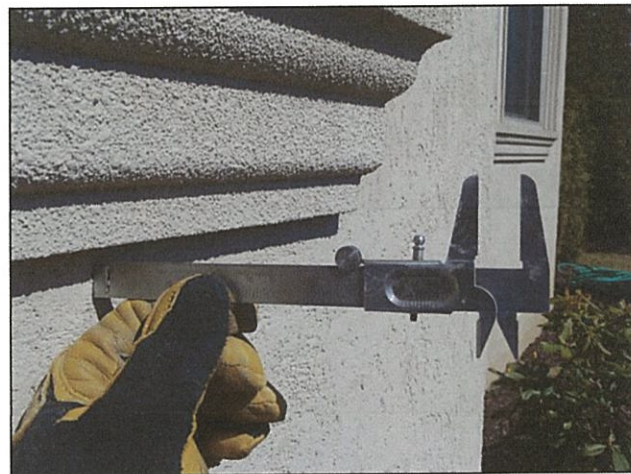
3.0 Item 12(Picture) Stucco measured 1/2" thick in most locations

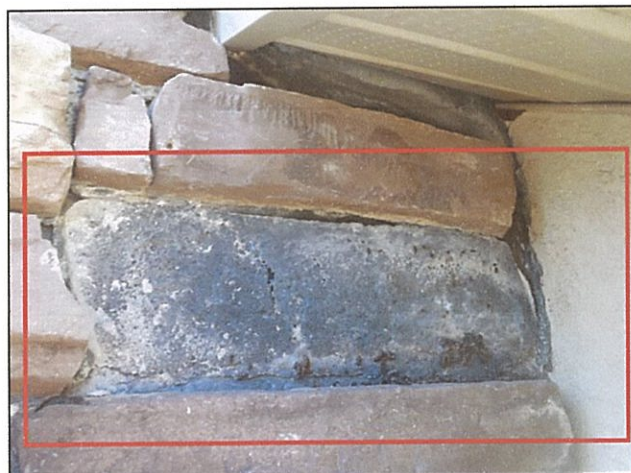
3.0 Item 13(Picture) Veneer stone on right side of chimney was loose and detached, stone was re-set

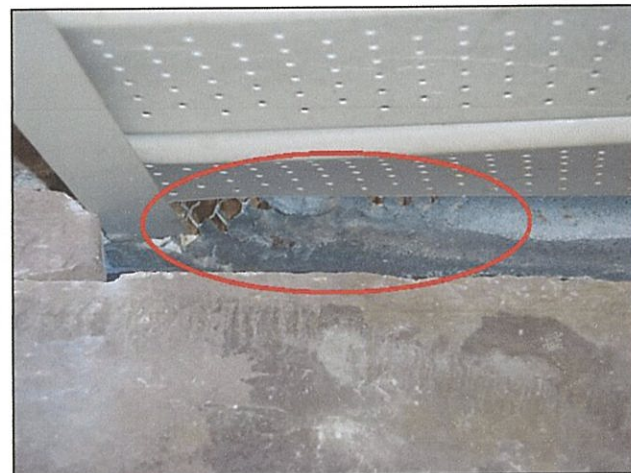
3.0 Item 14(Picture) Wire lath and OSB visible under soffit on chimney

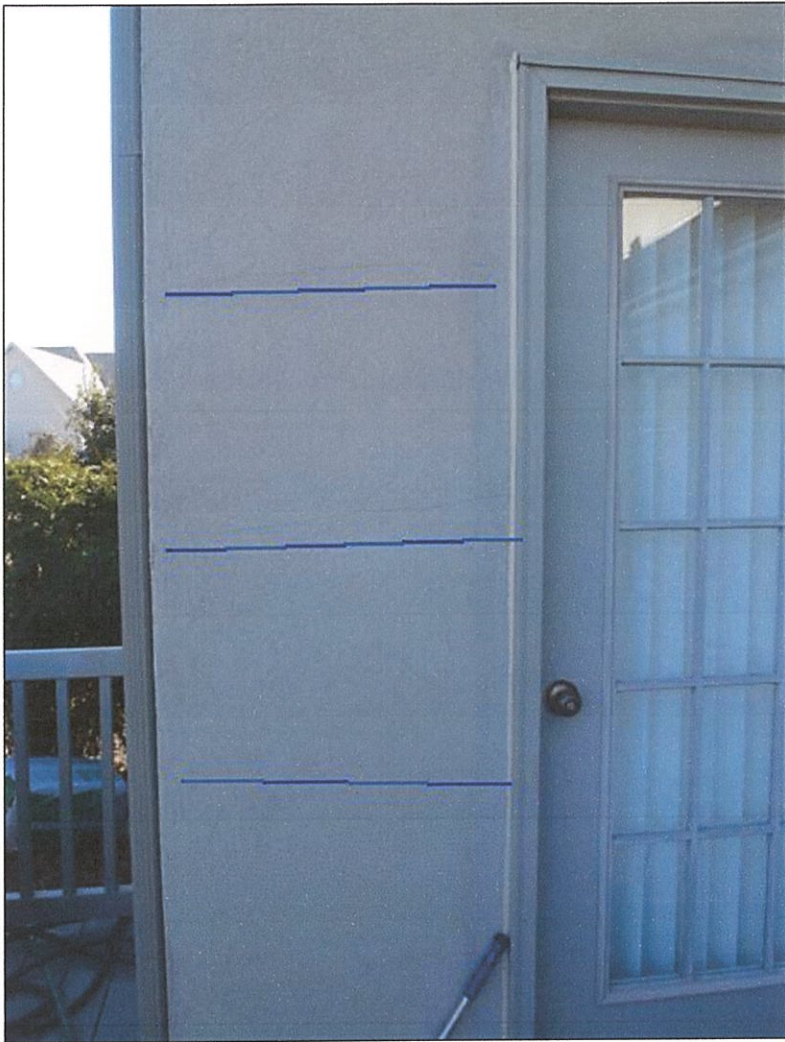
3.0 Item 15(Picture) Multiple cracks noted on left and right side of sunroom deck entry door

Comments: Yes

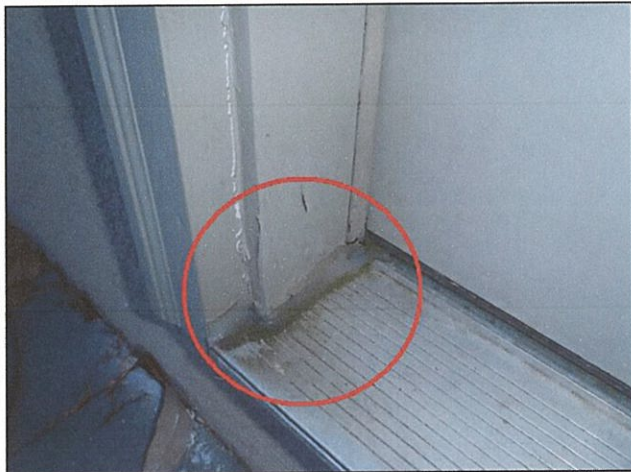
3.0 Item 16(Picture) Moisture damage and heavy sealant on sunroom deck entry door

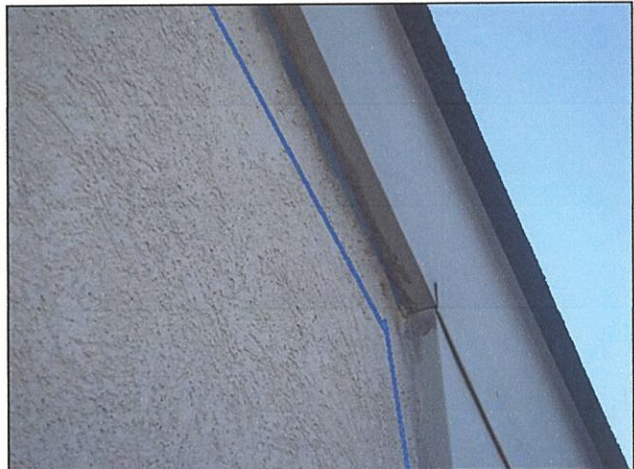
3.0 Item 17(Picture) Fascia & rake trim was caulked at stucco intersection

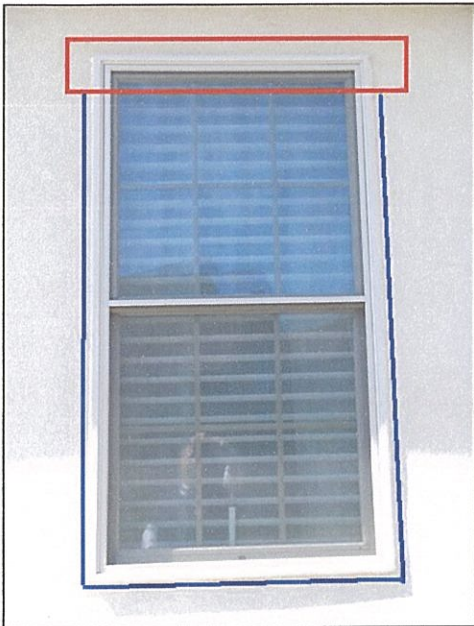
3.0 Item 18(Picture) No head flashing above windows or soft joints were installed on sides/bottom of windows

Comments: NO

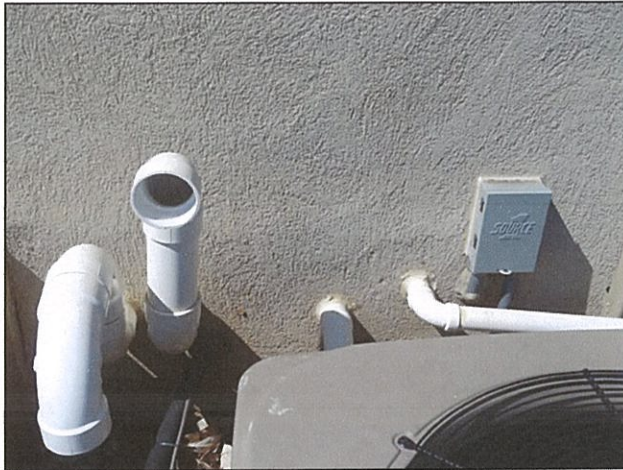
3.0 Item 19(Picture) No flashing boxes were installed on exterior penetrations
