Daybreak Home Inspections, Inc.
101 Colonial Dr.
Perkiomenville, PA 18074
Prepared by: Nicholas Frey
ASHI #: 262051 EDI #: PA-158

Home Inspection Report

25 Douglass Rd.
Lansdale , PA 19446

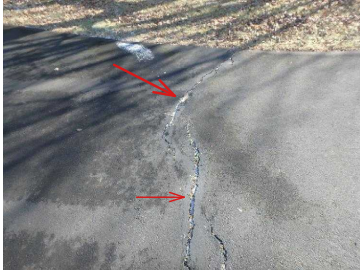
1. Driveway: Asphalt - Recommend sealing cracks in driveway to prevent further damage.

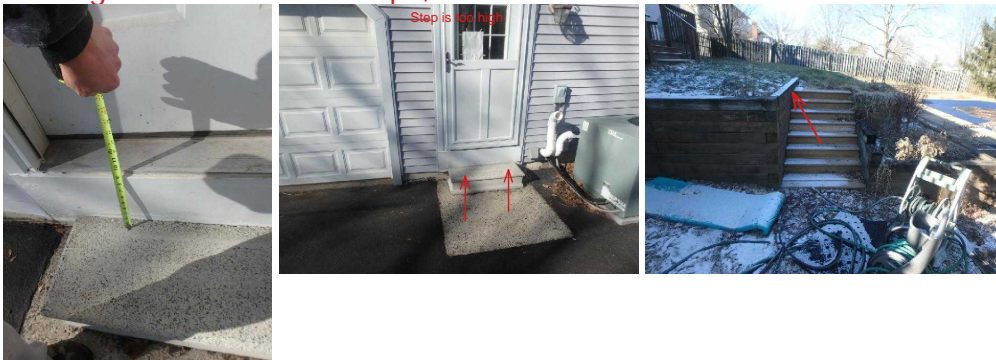
3. Steps/Stoops: Concrete - Step is too high at side door, height of steps should be 7 3/4 inches, recommend repair to reduce the risk of injury.

Missing handrail at rear steps, recommend installation to reduce the risk of injury.

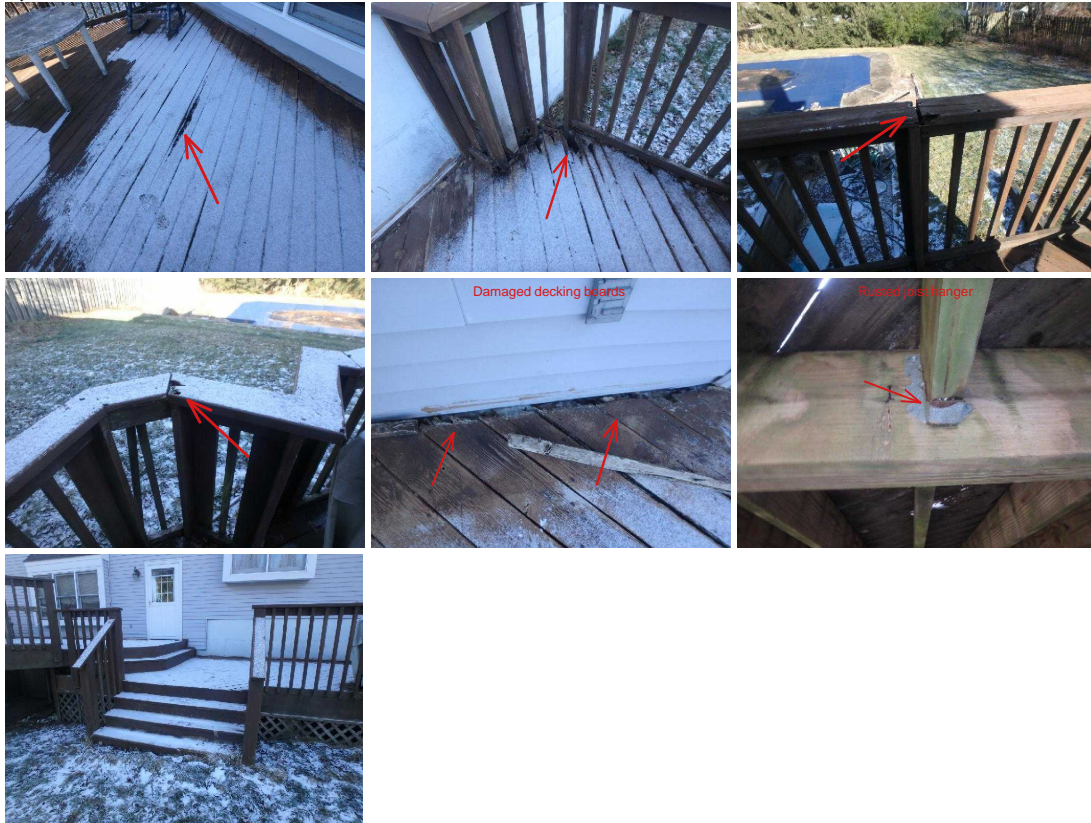
6. Deck: Treated wood - Damaged decking boards noted throughout deck, recommend replacement of all effected decking boards to reduce the risk of injury.

Damaged guardrails noted in numerous areas of deck, loose/missing balusters, recommend repair/replacement of wood to reduce the risk of injury.

Missing graspable handrail on deck stairway, recommend installation to reduce the risk of injury.

Rust noted on some joist hangers, rust can effect the integrity of the joists hanger, recommend replacement of all effected hangers.

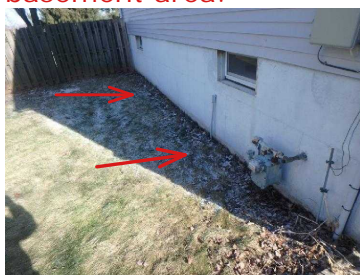
7. Grading: Negative slope - Improper soil slope towards foundation, recommend the addition of fill dirt to improve grade to help reduce moisture from entering the basement area.

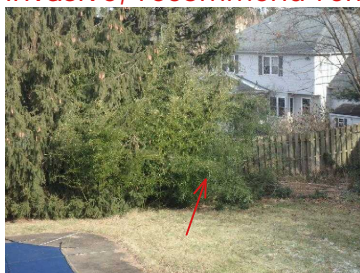
8. Vegetation: Trees, Shrubs - Bamboo noted at rear of yard, this plant is extremely invasive, recommend removal by landscaper.

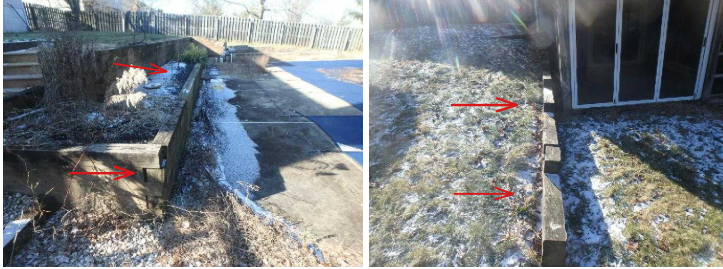
9. Retaining Walls: Wood - Wood retaining walls are bowing inward, due to poor drainage, recommend evaluation and repair by landscaper to prevent further damage.

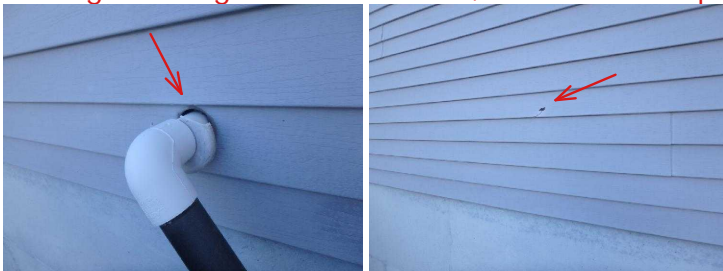
1. Type: Vinyl siding, Stone veneer - Seal around sump pit discharge/ penetrations in vinyl siding and stone veneer to reduce the risk of moisture/insect infiltration.

Damaged siding at rear of house, recommend repair

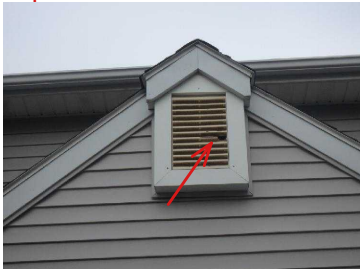
2. Trim: Aluminum, Vinyl - Damaged gable vent at front of house, recommend replacement to reduce the risk of critters entering the house.

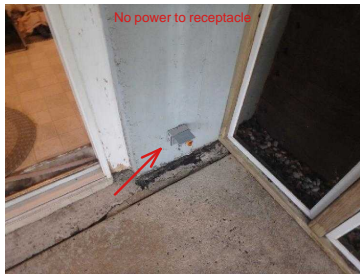
- 8. Basement Windows: Non-opening
- 9. Exterior Lighting: Surface mount
- 10. Exterior Electric Outlets: 120 VAC GFCI - No power noted to rear patio receptacle, recommend replacement of GFCI receptacle to allow for proper operation.

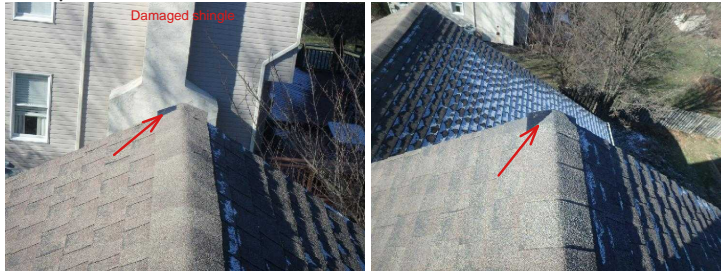
- 3. Material: Asphalt shingle - Damaged shingles at the ridge of house, recommend replacement of shingle to reduce the risk of water infiltration.

Shingles are existing beyond design life, roof granules are worn in numerous areas, this may cause shingles to deteriorate, recommend evaluation by roofer and budgeting for replacement

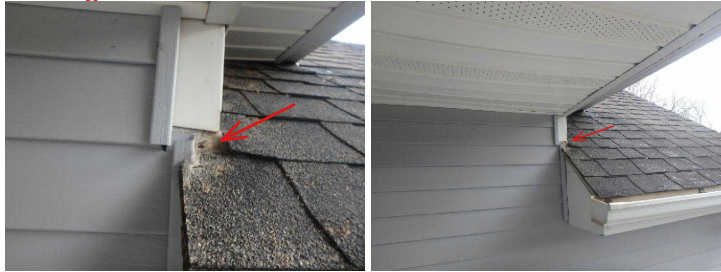
6. Flashing: Aluminum - Area was caulked heavily with noted hole, this may be an area where water may infiltrate, recommend repair by roofer to reduce the risk of water damage.

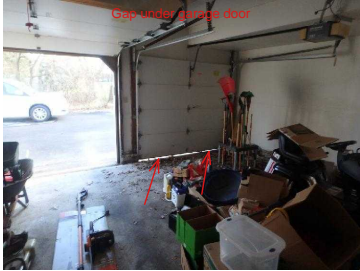
1. Type of Structure: Attached Car Spaces: 2
2. Garage Doors: Insulated aluminum - Gap noted under right garage door, recommend repair to reduce the risk of critters entering the house.

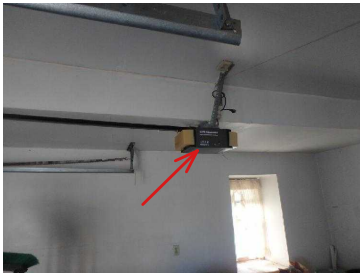
3. Door Operation: Mechanized
4. Door Opener: Lift Master, Chamberlain - Lift master opener was unplugged at time of inspection, recommend ensuring operation/replacement of garage opener by contractor.

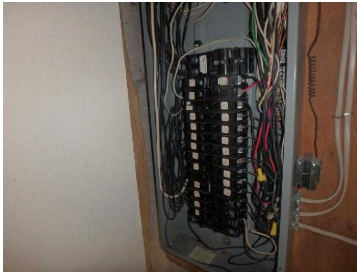
9. Manufacturer: Crouse-Hinds - **Missing panel cover screws, recommend installation.**

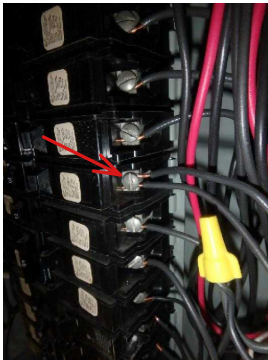
10. Maximum Capacity: 200 Amps
11. Main Breaker Size: 200 Amps
12. Breakers: CU/AL - **Double tap wiring, recommend repair by electrician.**

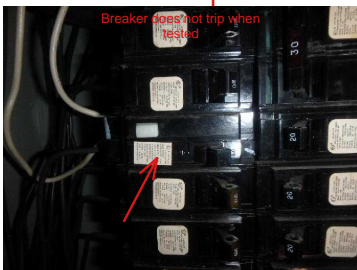
13. GFCI: At GFCI receptacles, Present - **GFCI Breaker did not trip when tested, recommend replacement to reduce the risk of shock.**

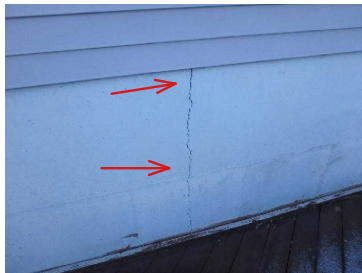
1. Structure Type: Wood frame
2. Foundation: Concrete - Vertical crack with no displacement noted at the exterior of rear foundation wall, recommend epoxy injection/sealing crack by basement/foundation contractor to reduce the risk of moisture entering the basement.

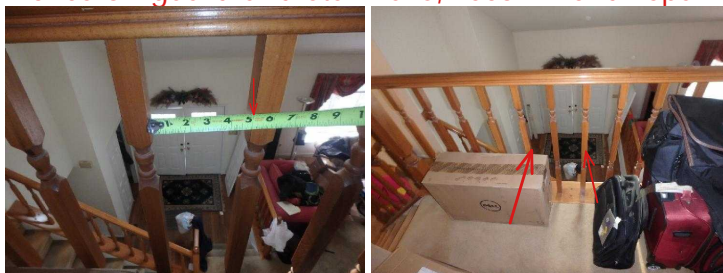
3. Differential Movement: No movement or displacement noted
4. Beams: Bonded wood
5. Bearing Walls: Frame
6. Joists/Trusses: 2x10, Trusses
7. Piers/Posts: Steel posts
8. Floor/Slab: Poured slab
9. Stairs/Handrails: Wood stairs with wood handrails - Baluster spacing is greater than 4 inches on guard and stair rails, recommend repair to reduce the risk of injury.

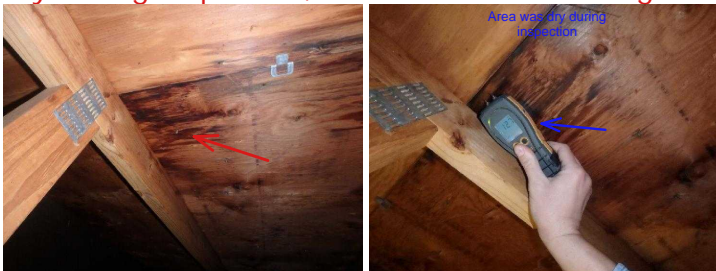
3. Roof Framing: Truss
4. Sheathing: Plywood - Water stain noted on plywood right above attic hatch, area was dry during inspection, recommend monitoring/ evaluation by roofer.

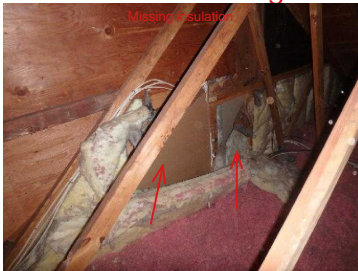
5. Ventilation: Gable, Ridge and soffit vents
6. Insulation: Blown in - Loose insulation noted, recommend repair to help conserve energy

Recommend adding insulation to help conserve energy

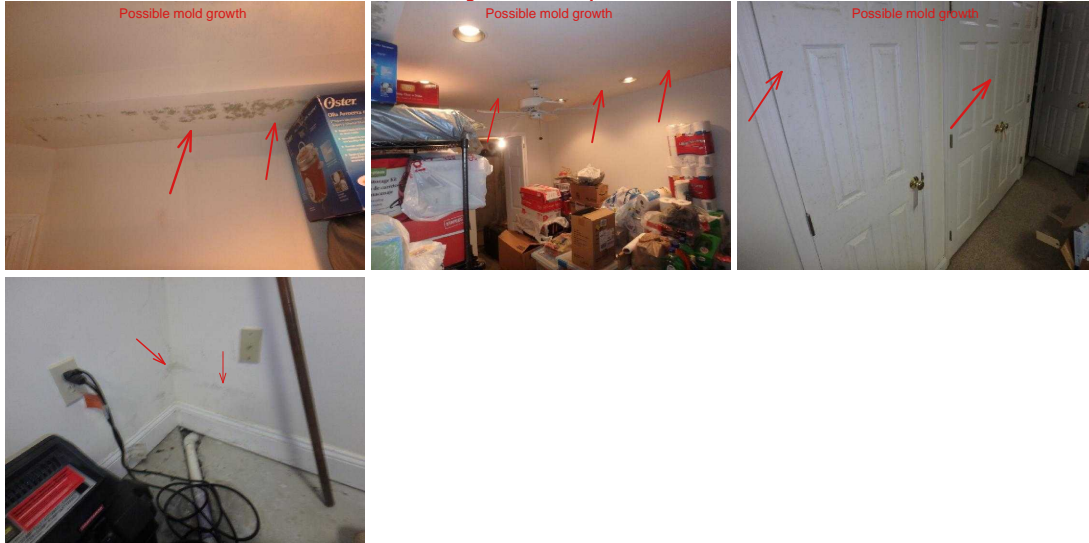
1. Unable to Inspect: 45% - Storage shelves, Storage boxes
2. Ceiling: Paint - Evidence of possible mold growth noted on drywall in storage room and closet doors, possibly due to elevated humidity in basement, recommend running a dehumidifier, and evaluation by mold specialist.

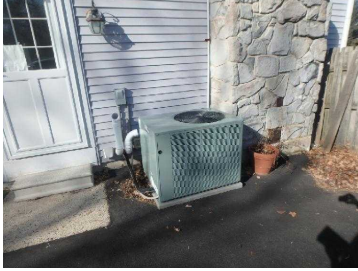
1. A/C System Operation: Appears serviceable - **To avoid possible compressor damage due to outside temperature below 60 degrees, the unit was not tested, recommend servicing by HVAC contractor when temperature increases.**

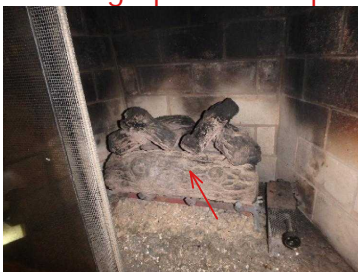
1. Fireplace Construction: Brick
2. Type: Gas log
3. Fireplace Insert: Standard - **Unable to light pilot light for gas insert, recommend ensuring operation/repair by fireplace specialist.**

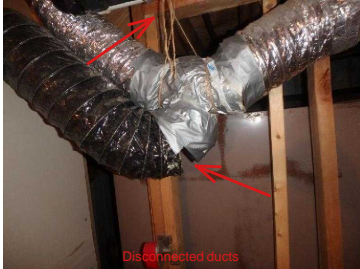
- 10. Distribution: Metal duct, Insulflex duct - **Disconnected duct work at front of basement, recommend repair to help conserve energy.**

Duct work was attached to drain line, recommend improvement to reduce the risk of disconnecting drain line

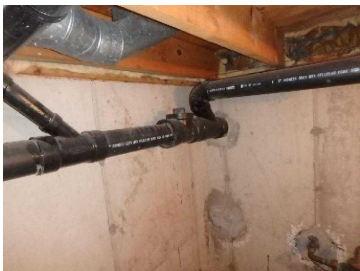
- 3. Water Lines: Copper
- 4. Drain Pipes: ABS, PVC
- 5. Service Caps: Accessible - Due to the age of house, recommend sewage lateral inspection of main drain line to ensure there are no blockages.

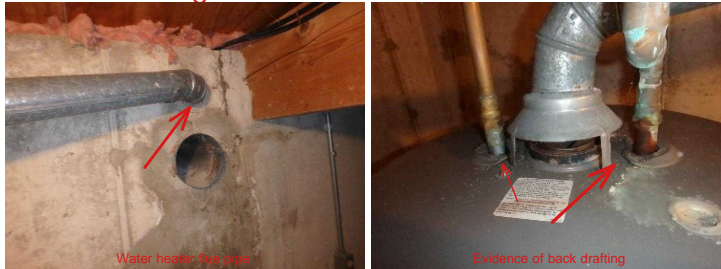
8. Water Heater Operation: Adequate - **Missing expansion tank on water heater, check valve was installed on main water, recommend installation of expansion tank by plumber.**
9. Manufacturer: Rheem
10. Model Number: XG50T12HE40U0 Serial Number: A081500051
11. Type: Natural gas Capacity: 50 Gal.
12. Approximate Age: 7 years Area Served: Whole building
13. Flue Pipe: Single wall - **Furnace was converted to high efficiency using PVC pipes, water heater still exhausting into terra-cotta liner in chimney. There is no longer enough BTU's to properly vent water heater and terra-cotta liner will eventually deteriorate, recommend installation of metal liner by chimney specialist to reduce the risk of carbon monoxide poisoning.**

Evidence of back drafting on water heater, recommend repair by plumber to prevent further damage.

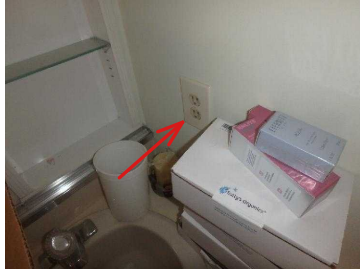
1. Ceiling: Paint
2. Walls: Paint
3. Floor: Vinyl floor covering
4. Doors: Hollow wood
5. Windows: Wood double hung
6. Electrical: 120 VAC - **Non-GFCI receptacle, recommend installation by electrician to reduce the risk of shock.**

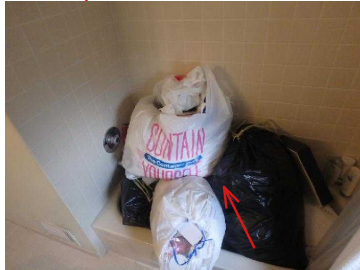
- 7. Counter/Cabinet: Laminate and wood
- 8. Sink/Basin: Molded dual bowl
- 9. Faucets/Traps: Moen fixtures with a ABS trap
- 10. Tub/Surround: Fiberglass tub and ceramic tile surround - Bags were in bathtub at time of inspection, unable to operate, recommend testing bath tub fixtures.

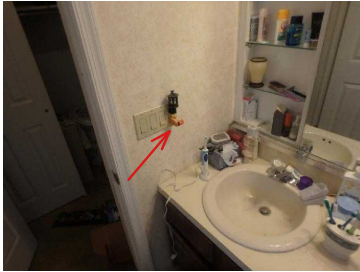
- 26. Ceiling: Paint
- 27. Walls: Paint
- 28. Floor: Vinyl floor covering
- 29. Doors: Hollow wood
- 30. Windows: Wood double hung - Windows over tub do not have tempered glass

installed, recommend installation of safety glazing/tempered glass to reduce the risk of injury.

31. Electrical: 120 VAC - Non-GFCI receptacle, recommend installation by electrician to reduce the risk of shock.

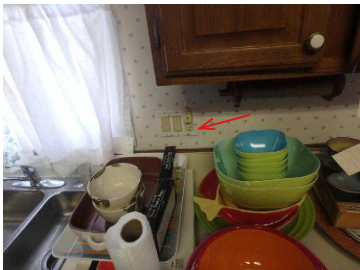
1. Cooking Appliances: Whirlpool - Missing anti-tip bracket, recommend installation to reduce the risk of injury.
2. Ventilator: Whirlpool
3. Disposal: In-Sinkerator
4. Dishwasher: Kitchenaid
5. Air Gap Present? Yes No
6. Microwave: Whirlpool
7. Sink: Stainless Steel
8. Electrical: 120 VAC - Non-GFCI receptacle near kitchen sink, recommend installation by electrician to reduce the risk of shock.

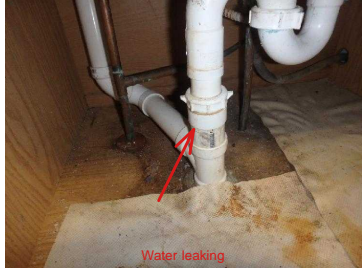
9. Plumbing/Fixtures: PVC - **Water leak noted at drain line, recommend repair to reduce the risk of water damage.**

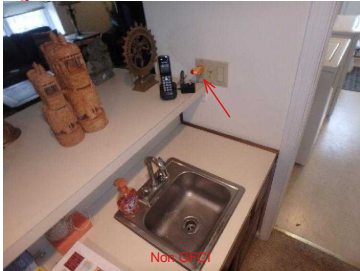
1. Closet: Single
2. Ceiling: Paint
3. Walls: Paint
4. Floor: Carpet - This inspection does not cover any damage concealed by carpeting, rugs or furniture
5. Doors: Hollow wood
6. Windows: Wood double hung
7. Electrical: 120 VAC - **Non GFCI receptacle near wet bar sink, recommend installation by electrician to reduce the risk of shock.**

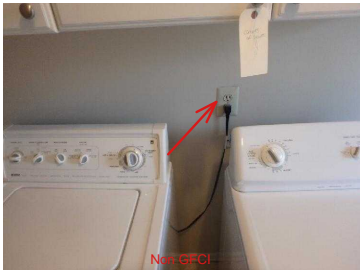
1. Ceiling: Paint
2. Walls: Wallpaper, Paint
3. Floor: Vinyl floor covering
4. Doors: Hollow wood
5. Electrical: 120 VAC - **Non-GFCI receptacle near laundry tub, recommend installation by electrician to reduce the risk of shock.**

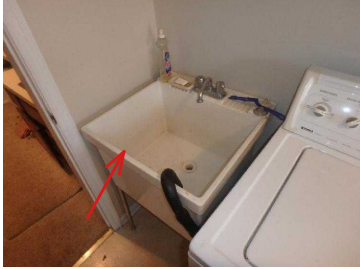
7. Laundry Tub: PVC - **Not mounted to floor or wall, recommend securing laundry tub to reduce the risk of disconnecting plumbing lines.**
