June 18, 2018

Alderfer Auction

Location: 1044 Gravel Pike, Palm Pa

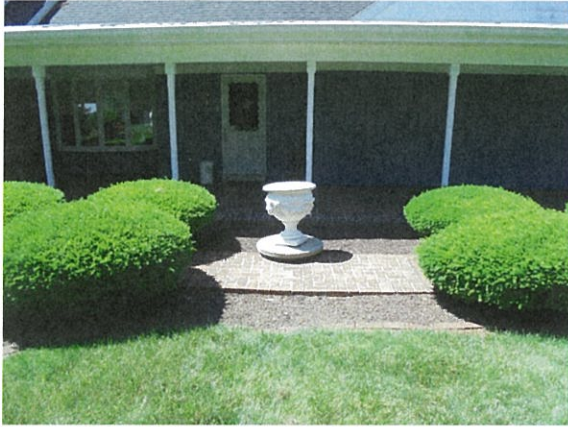
**Location of first septic tank**

to separate from the liquids to allow the partially treated effluent to discharge into an absorption area. The main cover of the septic tank was exposed which revealed a concrete tank that was at normal operating level. The inlet baffle is present and in good. The septic tank will need to be pumped to check the integrity of the tank below the liquid level. At this time the outlet baffle will be inspected. The washing machine gray water is connected to the septic system.

We are unable to verify that the on-lot wastewater treatment system is presently in satisfactory condition as further investigation is needed. The absorption area will need to be located and the septic tank will need to be pumped and inspected.

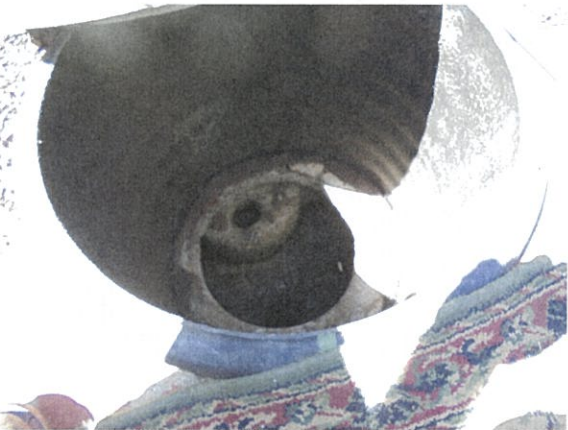
**Inlet Baffle**

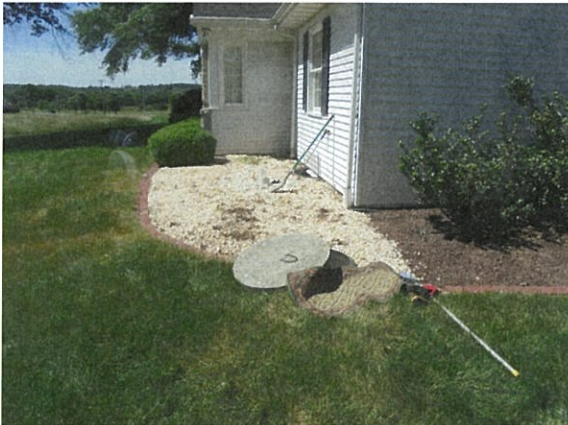
**Location of second tank**

The septic system consists of a 1000-gallon (+/-), single-compartment septic tank that clarifies the wastewater passing through it. This tank is water tight and allows the solids to separate from the liquids to allow the partially treated effluent to discharge into an absorption area. The main cover of the septic tank was exposed which revealed a concrete tank that was at normal operating level. The inlet and outlet baffles were present and in good. The septic tank will need to be pumped to check the integrity of the tank below the liquid level.

We are unable to verify that the on-lot wastewater treatment system is presently in satisfactory condition as further investigation is needed. The absorption area will need to be located and the septic tank will need to be pumped and inspected.
