# Home Inspection Report

21116 Marlin Circle, Shade Gap, PA 17255

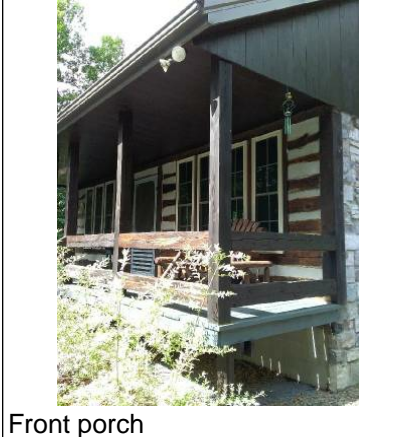
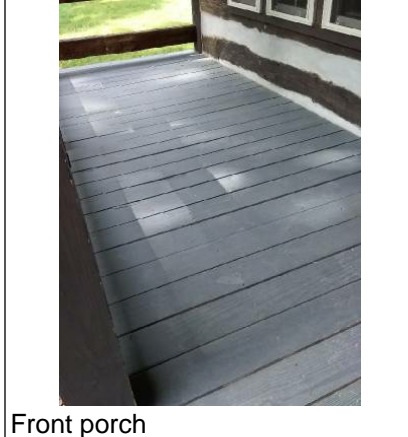
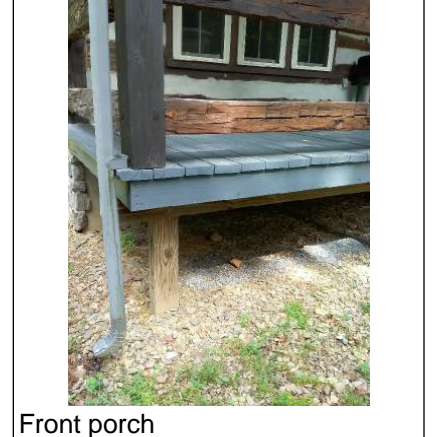
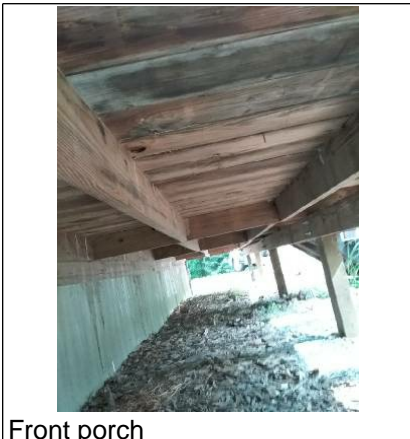
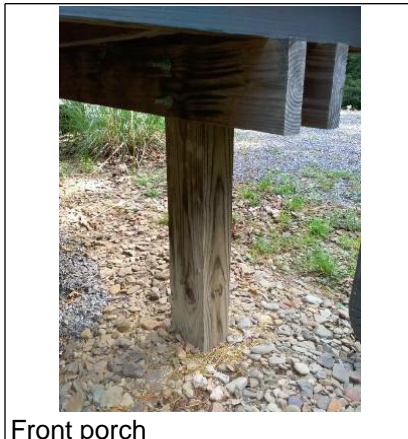
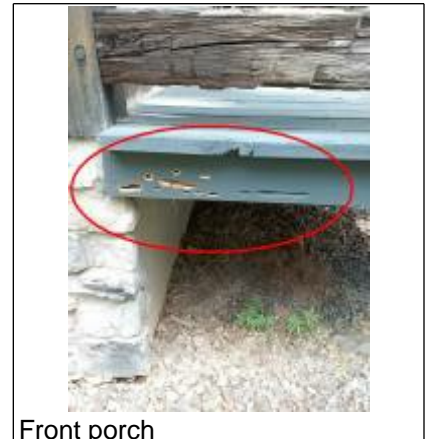
Front porch

**Comments** There is minor bee/woodpecker damage on front and rear porch -recommend keeping these areas sealed / stained to prevent any further activity.

The front porch top rail on the northern end of the front porch has minor damage- recommend repair
