830 Covington Grove Court, Bowling Green, KY

Property Inspection Report

**830 Covington Grove Boulevard
Inspection Prepared For: Ana Marie Gierhart
Agent: Tyler Chamings -**

**Date of Inspection: 9/13/2024
Year Built: 1995 Size: 6598
Weather: Cloudy/Raining and 76 degrees**

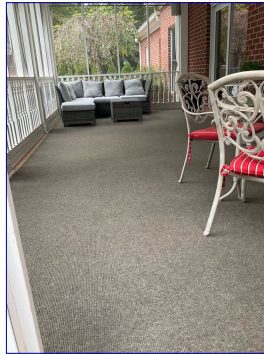
• The patio was covered with a rug/carpet. Limited visibility. Some defects may exist that were not visible during the home inspection. Recommend monitoring. Consult a professional contractor as needed.

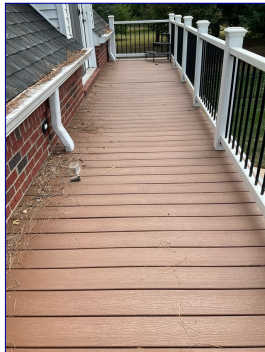
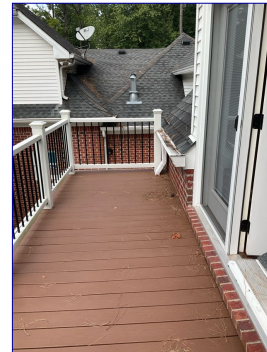
- The underside of the balcony was covered and not visible, no representation can be made to the condition of the under structure

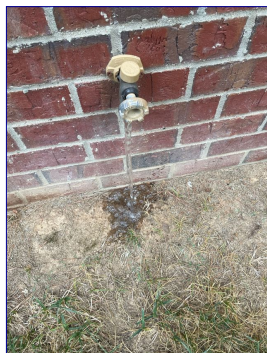
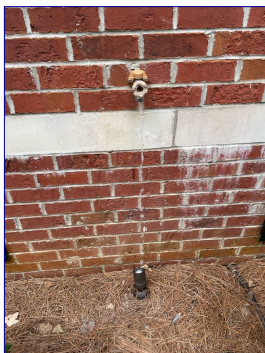
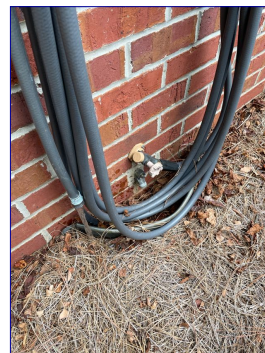
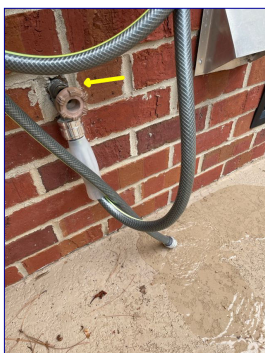
- **The hose bib is not secured to the house, which may cause damage over time. Recommend securing the hose bib to the house.**

Not properly secured

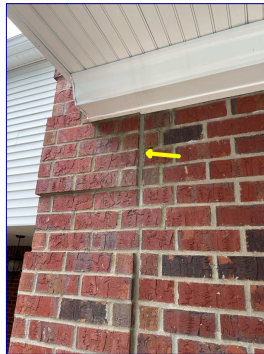
Cracks

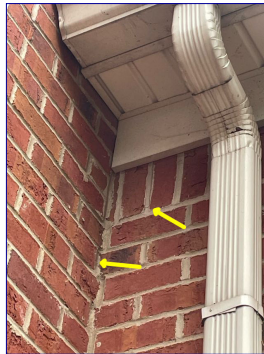
Cracks

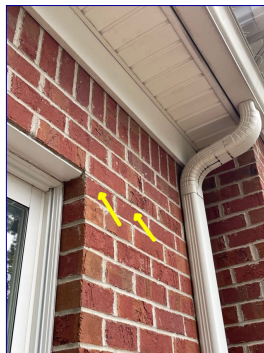
Cracks

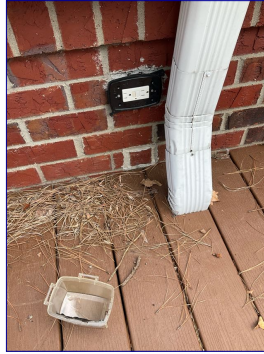
- Receptacles/Condition:
- Exterior receptacles: Yes
 - Exterior receptacles, operable: Yes
 - GFCI present: Yes
 - GFCI, operable: Yes
- Observations:
- The weather cover for the exterior outlet on the balcony of the suite is broken and needs to be replaced

Broken weather cover

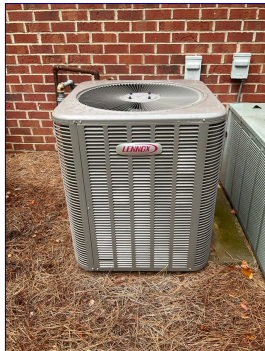
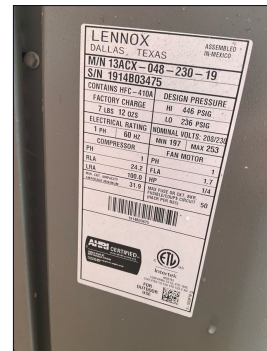
- The air conditioning condenser coils are dirty. Recommend cleaning. Consult a professional contractor as needed.

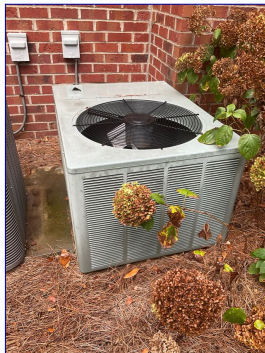
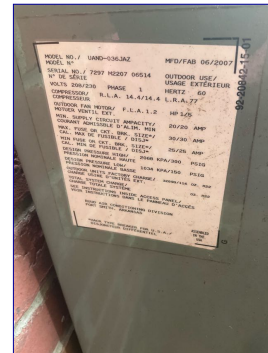
- The air conditioning condenser coils are dirty. Recommend cleaning. Consult a professional contractor as needed.

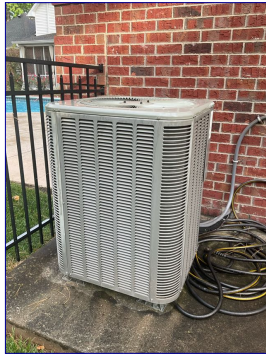
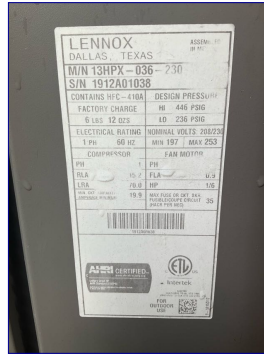
- There is damaged and/or missing insulation on the air conditioner refrigerant line. Recommend replacing insulation.

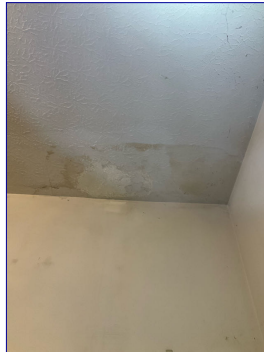
- There are moisture stains/damage noted on the ceiling, this area is confirmed dry at the time of inspection, recommend a qualified contractor to evaluate further and repair as needed

Moisture stains/damage

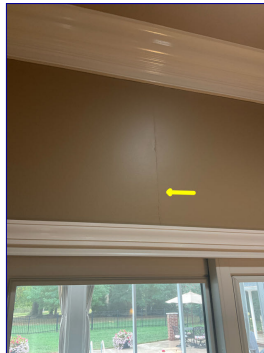
- Condition:
- Typical cracks
- Observations:
- There are typical cracks on the walls/ceilings. Monitor and repair as needed.

Typical crack

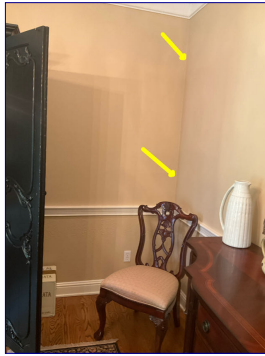
- There are cracks and wrinkled wallpaper noted in the corner of the dining room (pictured) which are signs of settling, recommend further evaluation by qualified contractor and repair if needed

Cracks and wrinkled wallpaper

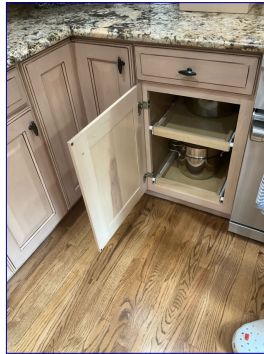
- The kitchen cabinet hinges are loose. Recommend hinges be tightened.

Loose cabinet hinges

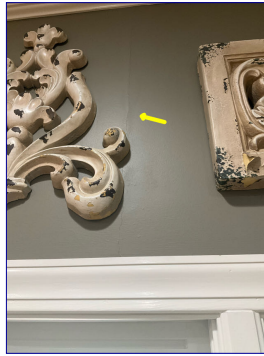
- Typical cracking present in the kitchen walls/ceiling. Recommend monitoring and repair as needed.

Typical crack

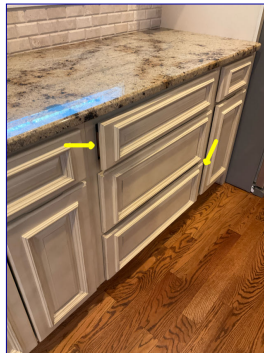
- Recommend repair/adjustment

Drawers need to be adjusted

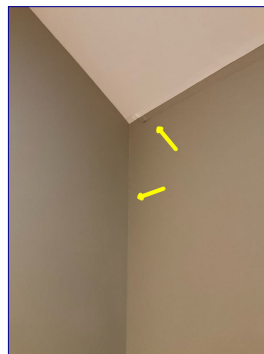
- There are loose tape seams, and settling cracks indicating settling, noted on the SW corner, recommended qualify contractor to evaluate and repair as needed

Loose tape seems and settling cracks

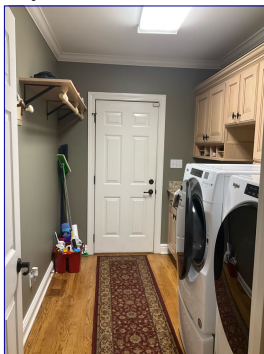
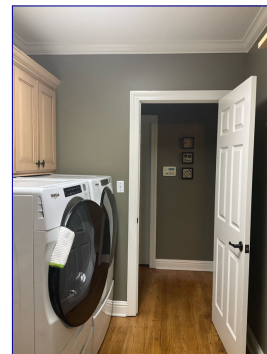
- The laundry room door does not latch properly, recommend repair

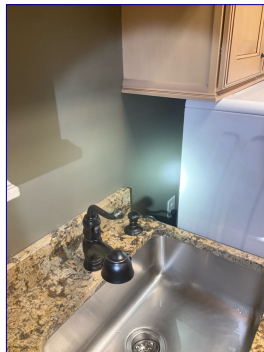
- Since there is a sink in the laundry room, the outlets should be GFCI protected, recommend an electrician to repair

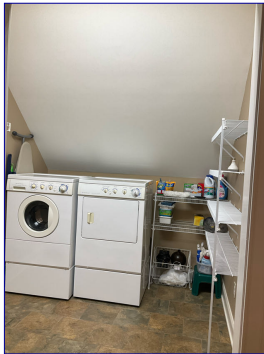
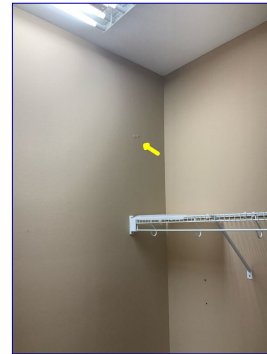
- Nail pops noted, recommend a qualified contractor to repair

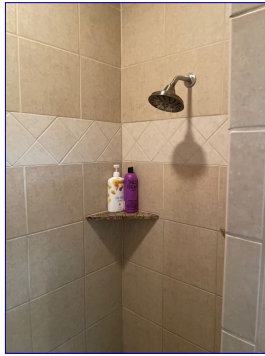
- Recommend caulking/grouting around the shower base to help prevent damage from water penetration.

Needs caulking/sealing

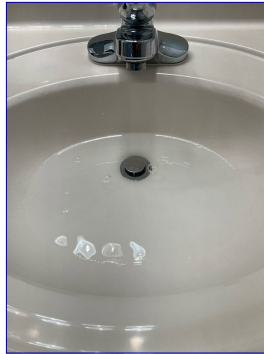
- Bathroom sink was not draining correctly, slow drain. Recommend clearing the clog and retesting. Consult a licensed plumber as needed.

Slow drain

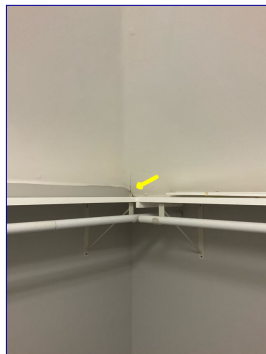
Typical crack

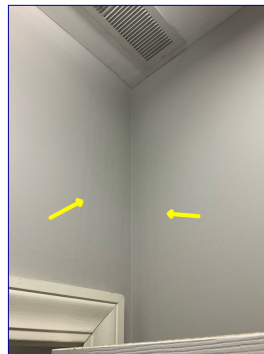
• There are moisture stains/streaking noted on the walls inside the closet, these appear to be caused from excessive moisture, coming from the HVAC unit, recommend the qualified contractor to evaluate further and recommend solutions

Moisture streaks

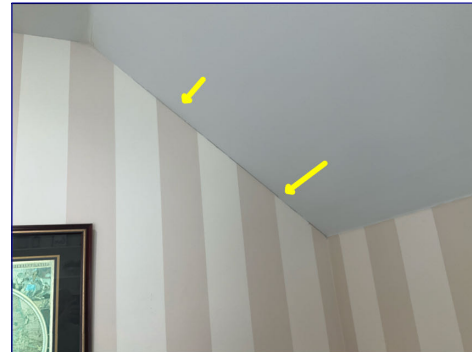
- There are settling cracks on the walls/ceilings. Consult with a professional contractor to repair as needed.

Signs of settling

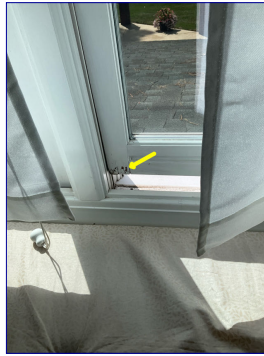
- The right window has moisture damage in the lower left corner, recommend a qualified contractor to repair/replace as needed

Moisture damage

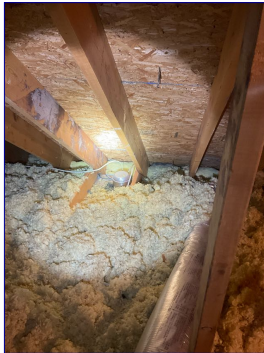
- The soffit vents, as viewed from the attic, are missing baffles. Recommend a professional contractor install baffles at the eaves for proper ventilation.

Missing baffles

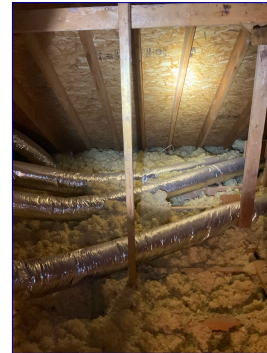
Missing baffles

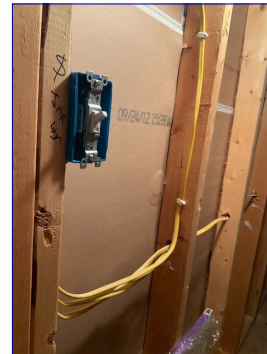
- There is a light switch plate missing in the attic accessible from the closet in the small suite bedroom
- There is at least one open junction box missing its cover in the attic, which is a safety concern. Recommend a licensed electrician install a cover plate.

Missing switch plate

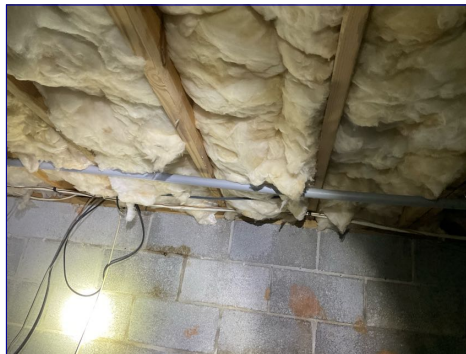
Joist view

- One or more areas of the joists were not visible due to insulation. Recommend monitoring. Consult a licensed contractor as needed.

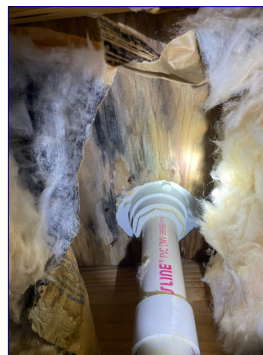
- **There is moisture staining/damage on the subfloor beneath the master shower, I let the shower run for an extended period of time and never did see a leak, recommend a qualified contractor to evaluate and repair as needed**

Moisture stains beneath the master shower

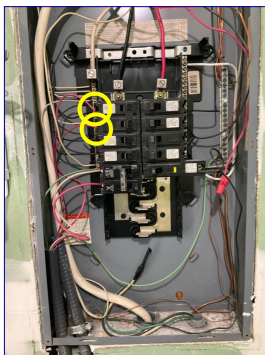
- Two of the breakers in the poolhouse, sub panel have been doubletapped, recommend an electrician to repair

Double tapped breakers

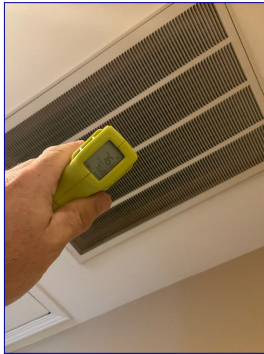
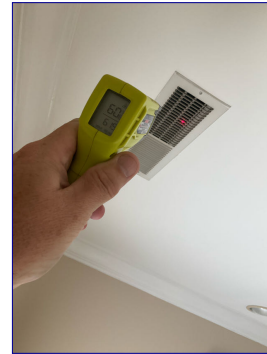
- Differential: 16 degrees

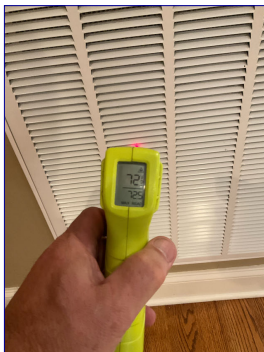
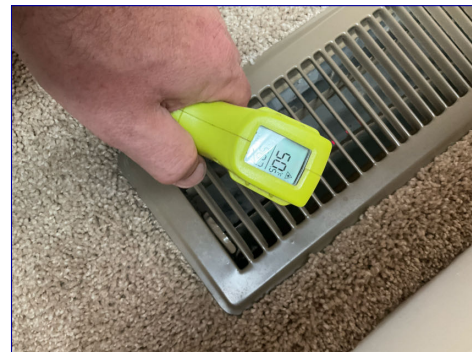
- Differential:
- Differential: 22 degrees
