HOME INSPECTION REPORT

On Monday, July 5, 2021 The HomeTeam Inspection Service made a visual inspection of 3465 Saigon Dr, Westerville, OH 43081. Enclosed please find a written, narrative report of our findings in accordance with the terms of our Inspection Agreement.

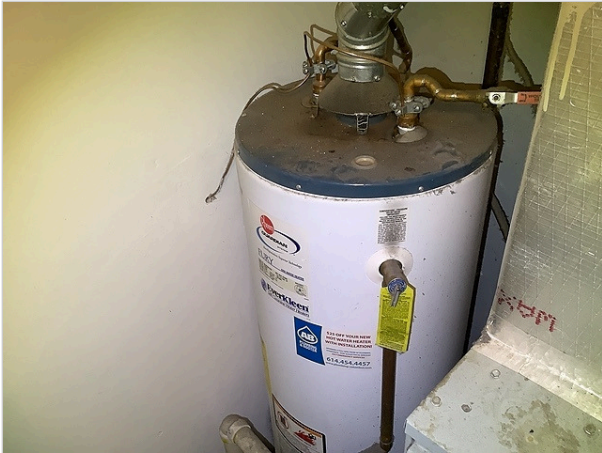
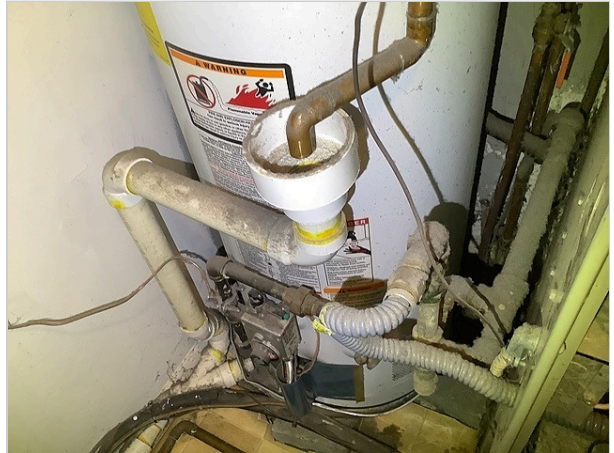
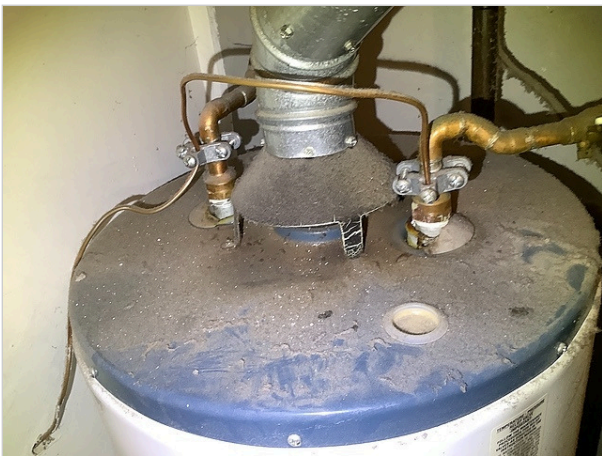
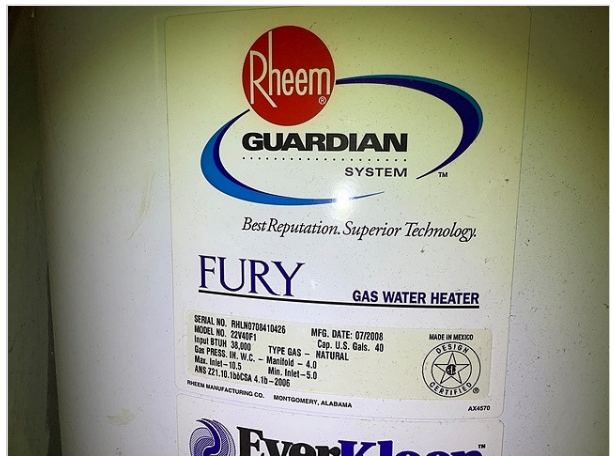
The water heater may be past its design life. This is an informational note only to help give an idea of future budgeting considerations. The unit was functional unless noted otherwise. Please note that since codes change, it is possible the configuration for a water heater's flue and/or discharge may need to be altered at the time of a future replacement.

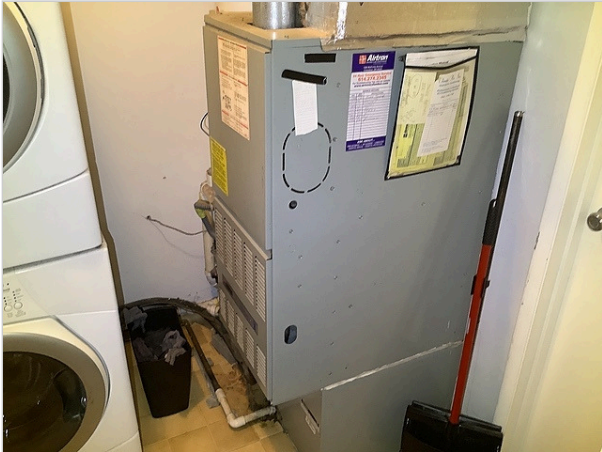
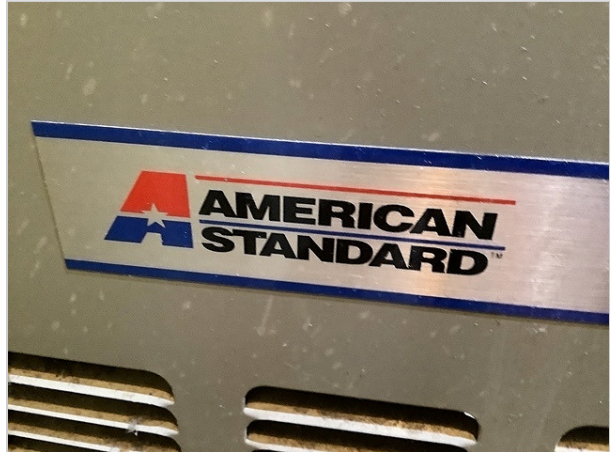
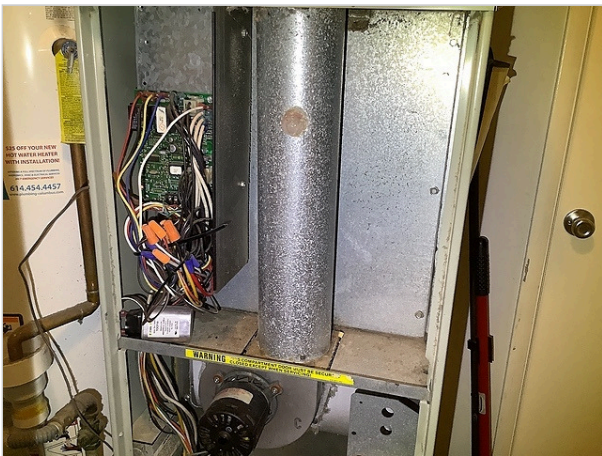
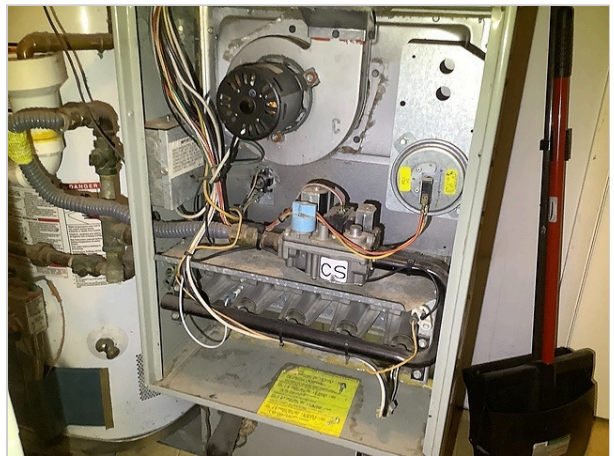
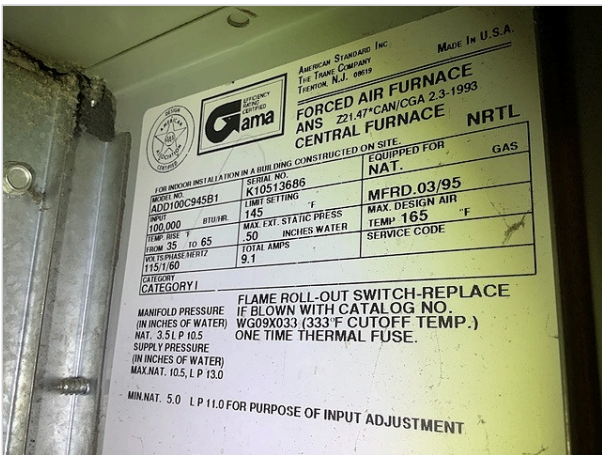
The furnace may be past its design life. This is an informational note only to help give an idea of future budgeting considerations. The system was functional at the time of the inspection unless noted otherwise. Please note that since codes change, it is possible the configuration for the flue and/or condensate lines may need to be altered at the time of a future replacement.

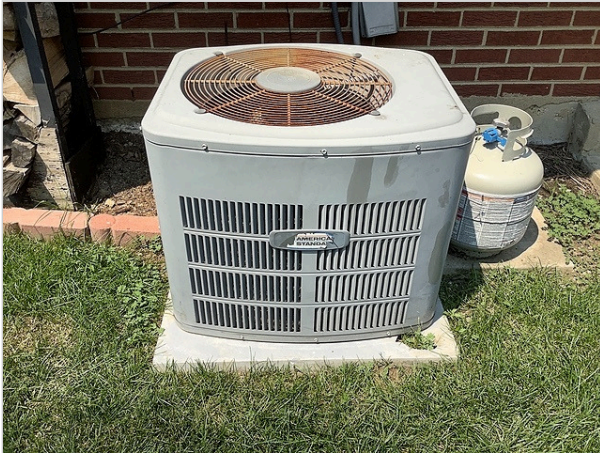
Photo 61

The air conditioner may be past its design life. Unless noted otherwise, the system was functional at the time of the inspection. As with a light bulb that functions normally one day but the next may not turn on, a system's age is a helpful factor that assists in budgeting for eventual replacement.

The insulation on the exterior air conditioning line set is missing. This could affect the efficiency of the system and should be replaced.

The condensate line for the HVAC system is discharging adjacent to the foundation. Condensate water is mildly corrosive and can cause damage to the foundation over time. The condensate drain line should be extended further away from the structure.
