Daybreak Home Inspections, Inc.
101 Colonial Dr.
Perkiomenville, PA 18074
Prepared by: Nicholas Frey
ASHI #: 262051 EDI #: PA-158

Home Inspection Report

25 Douglass Rd.
Lansdale , PA 19446

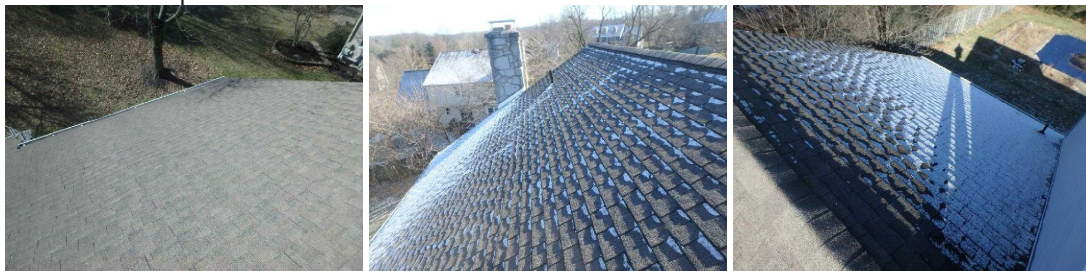
Main Roof Surface

- 3. Material: Asphalt shingle - Damaged shingles at the ridge of house, recommend replacement of shingle to reduce the risk of water infiltration.

Shingles are existing beyond design life, roof granules are worn in numerous areas, this may cause shingles to deteriorate, recommend evaluation by roofer and budgeting for replacement

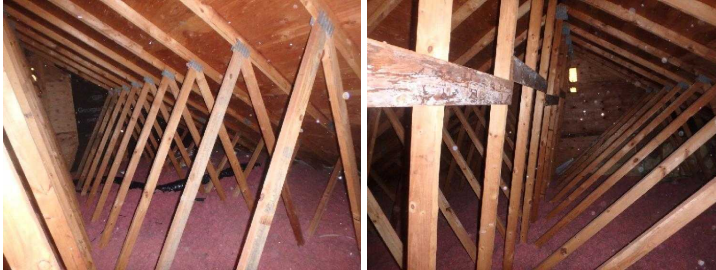
Main Attic

3. Roof Framing: Truss
4. Sheathing: Plywood - Water stain noted on plywood right above attic hatch, area was dry during inspection, recommend monitoring/ evaluation by roofer.

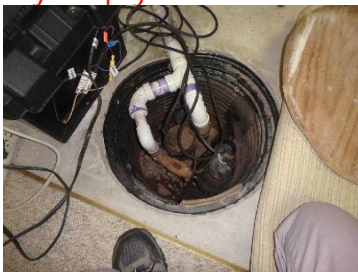
3. Walls: Paint
4. Floor: Carpet, Poured - This inspection does not cover any damage concealed by carpeting, rugs or furniture
5. Floor Drain: Covered
6. Doors: Hollow wood
7. Windows: Non-opening
8. Electrical: 120 VAC
9. HVAC Source: Electric baseboard
10. Insulation: Batting
11. Sump Pump: Submerged, Battery Backup - Sump crock was completely dry/empty-unable to test pump operation/piping for leaks
