# Home Inspection Report

21116 Marlin Circle, Shade Gap, PA 17255

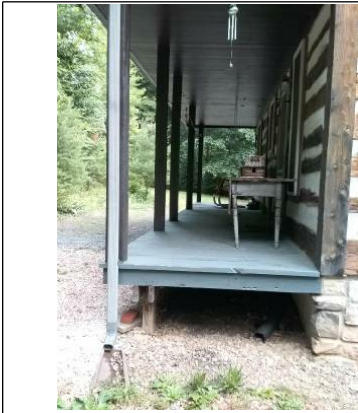
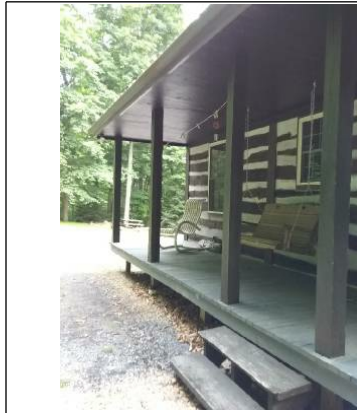
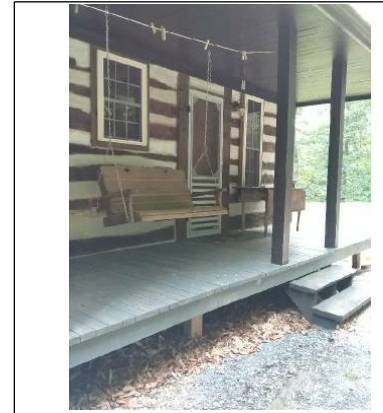
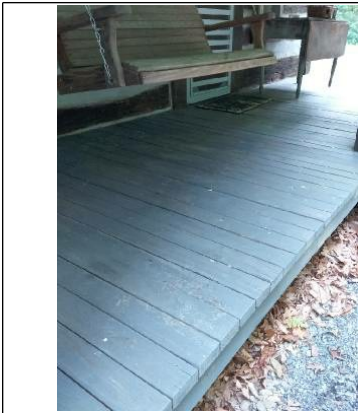
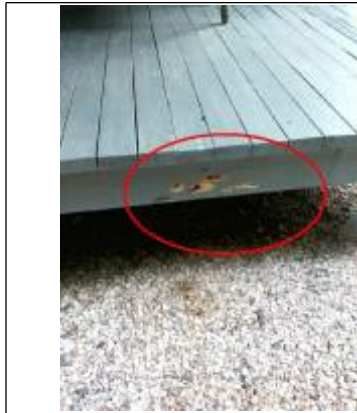
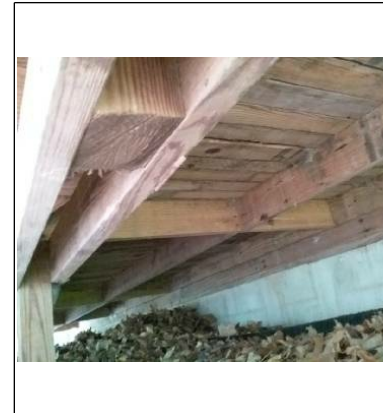
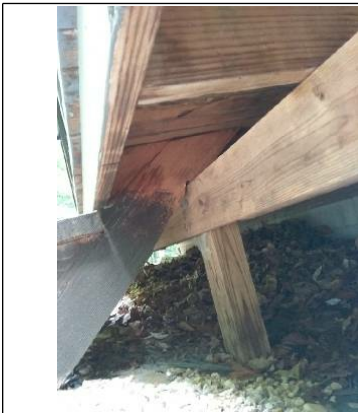
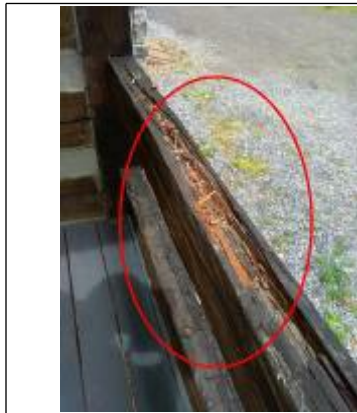
**Comments** There is minor bee/woodpecker damage on front and rear porch -recommend keeping these areas sealed / stained to prevent any further activity.

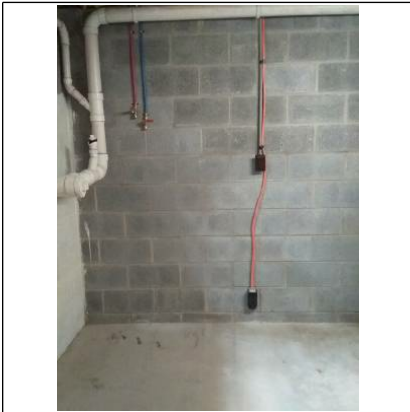
**Comments** There are facilities to hook up a laundry area in the basement

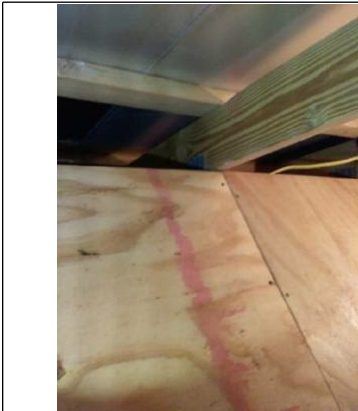
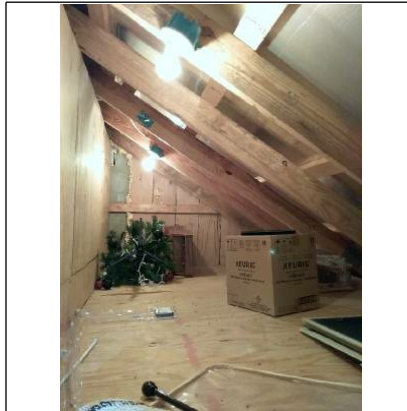
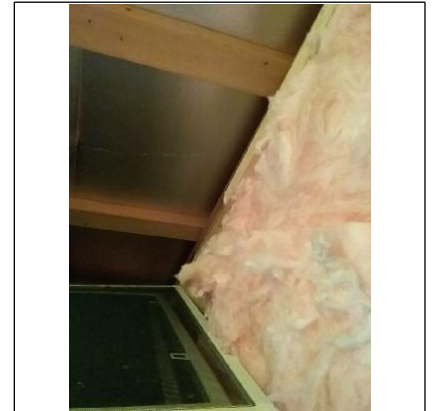
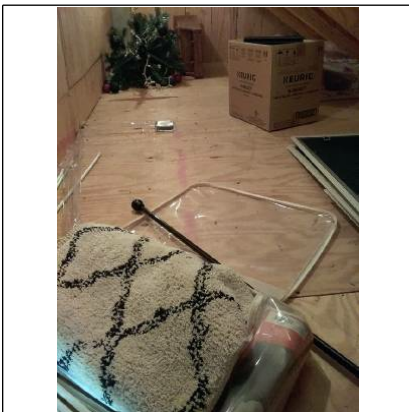
## Photos

**Comments** There is only a small section of attic present. The majority of the 2nd floor has vaulted ceilings and the framing, insulation etc. is unviewable

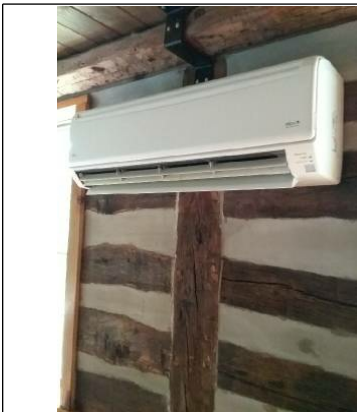
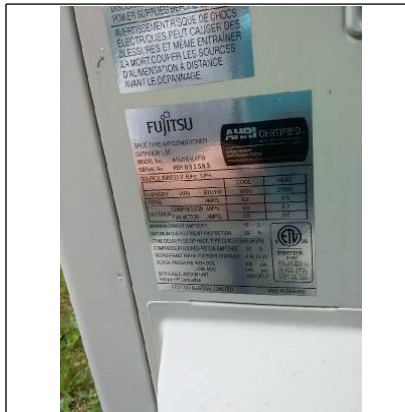
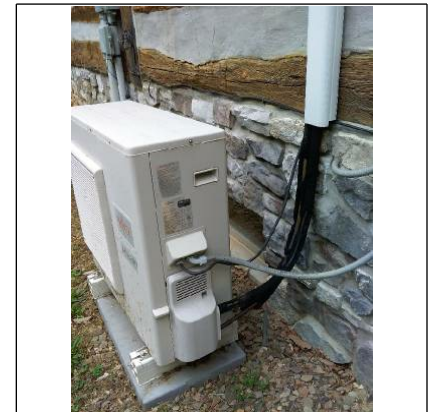
**Comments** The homes primary source of heat is a Fujitsu Mini Split that was working properly at the time of inspection.

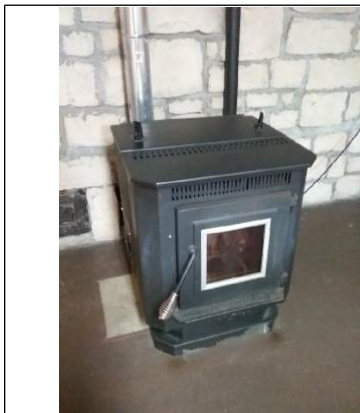
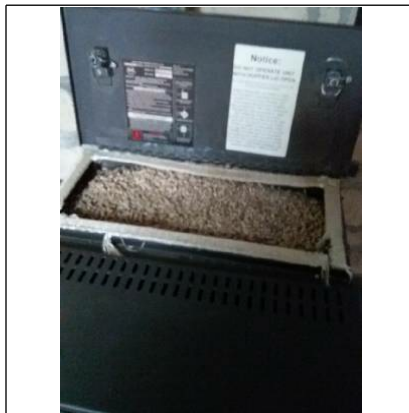
**Comments** There are two pellet stoves in the home, one in the first floor living room, and one in the basement in the family room. They both were in good physical condition, but they were not tested at the time of inspection
